# Phase 1 - Timber Groyne Repairs - Works Area 1

## Examples of the types of repair work which will be undertaken within this area

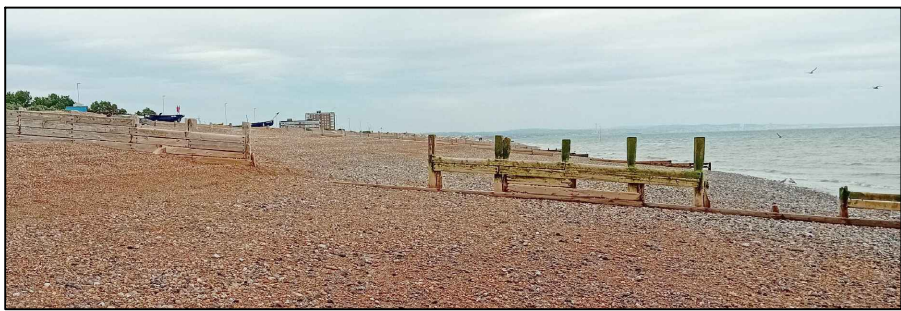
Photo of a groyne before works

The existing piles have snapped and the missing planks cannot be replaced. This has resulted in the shingle passing through the groyne and allowing the shingle beach and defence to erode.

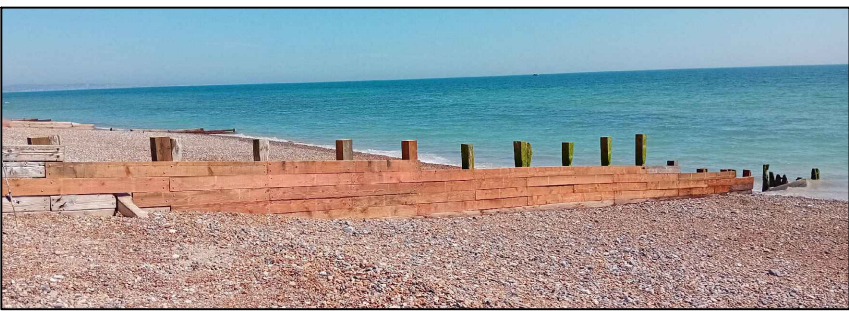
Photo of the same groyne immediately after the works were completed

The snapped piles have been extended/strengthened and the missing planks have been replaced. The shingle will naturally build up against the groyne.

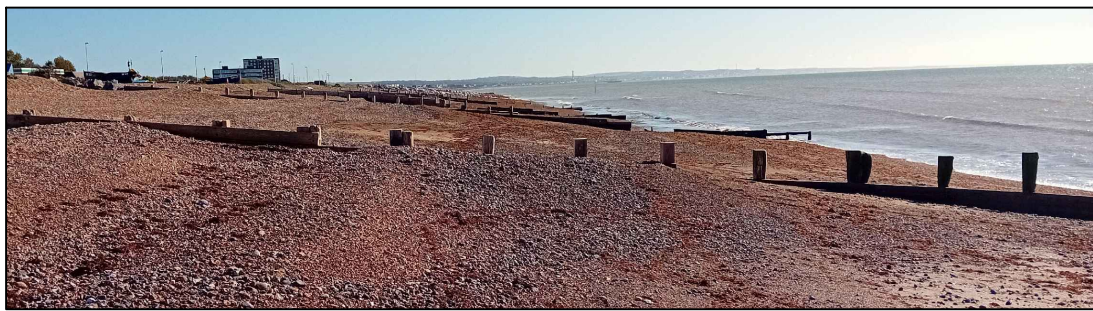
Photo of the same groyne two months after the works were completed

The shingle has naturally built up against the timber groyne. In the space of only two months the sea defence is back to its original condition.

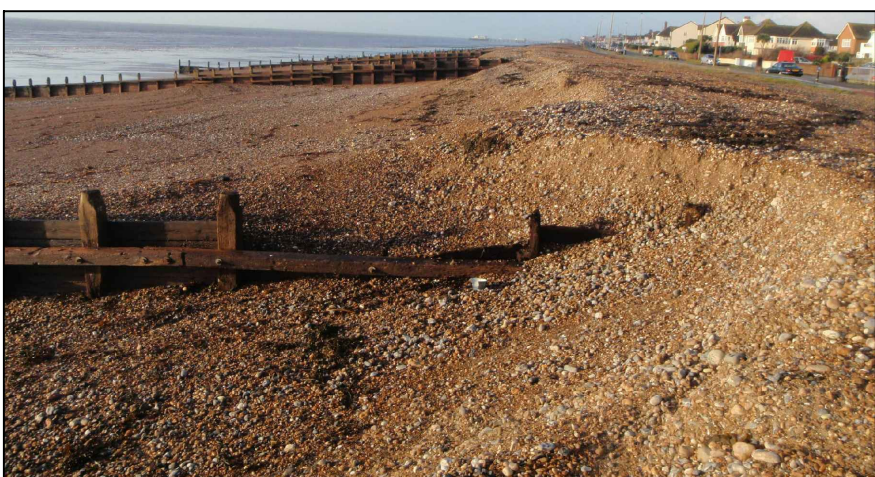
Photo of a groyne before works

The existing piles and planks at the landward end are completely rotten. During a storm the waves have washed away the timbers and eroded the beach as there is no structure to retain the shingle. This process is called outflanking.

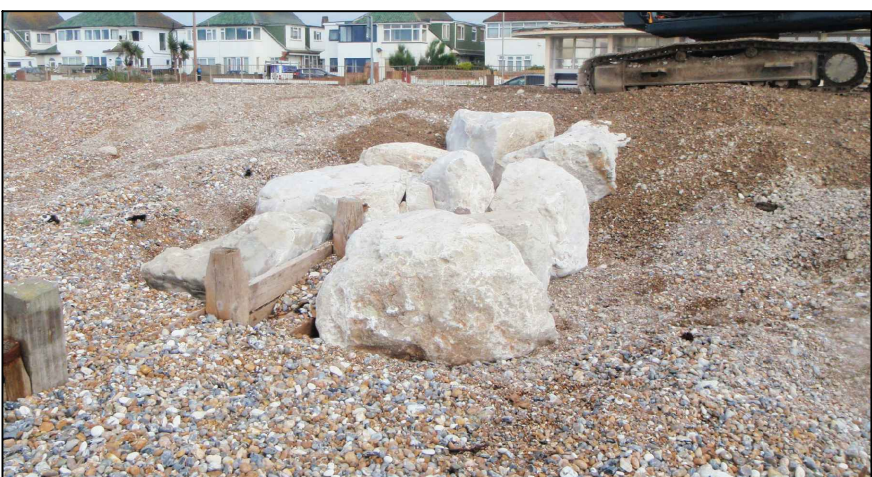
Photo of the same groyne once the rocks have been placed

Large limestone /granite rocks have been placed where the groyne was rotten. This will prevent outflanking during a storm. Once the rocks are positioned they are covered with shingle.

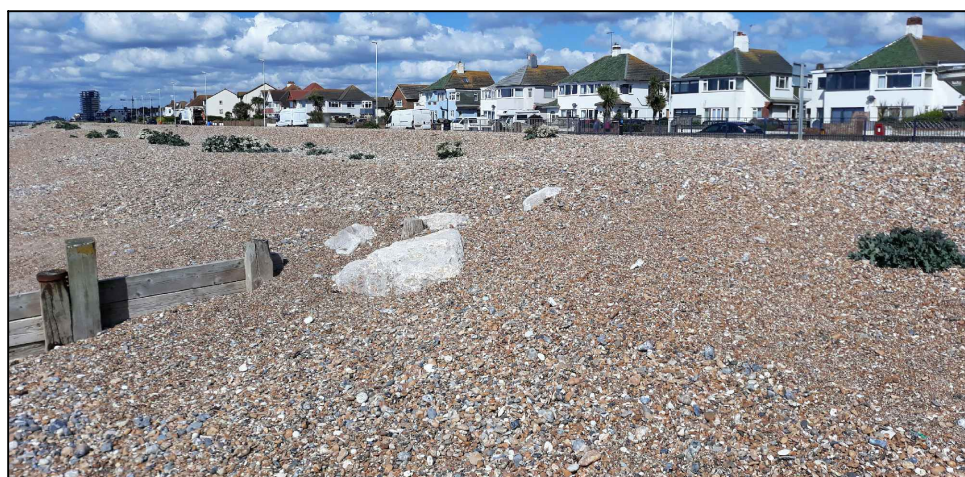
Photo of the same groyne five years after the works were completed

The same groyne five years later showing a nice stable shingle beach. Only a few of the rocks are visible.
