Phase 1 - Timber Groyne Repairs - Works Area 6

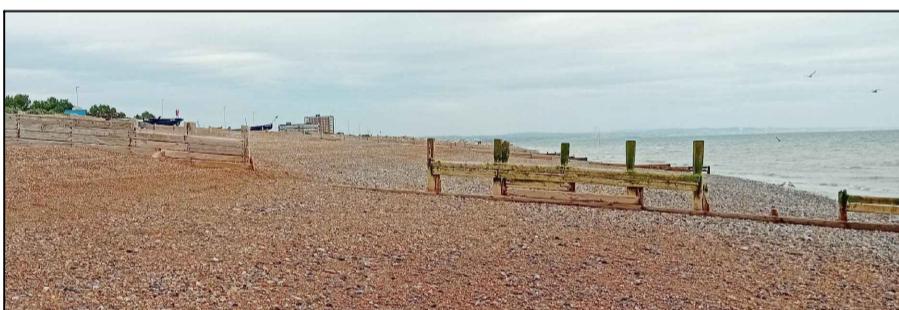
Photo of a groyne before works

The existing piles have snapped and the missing planks cannot be replaced. This has resulted in the shingle passing through the groyne and allowing the shingle beach and defence to erode.

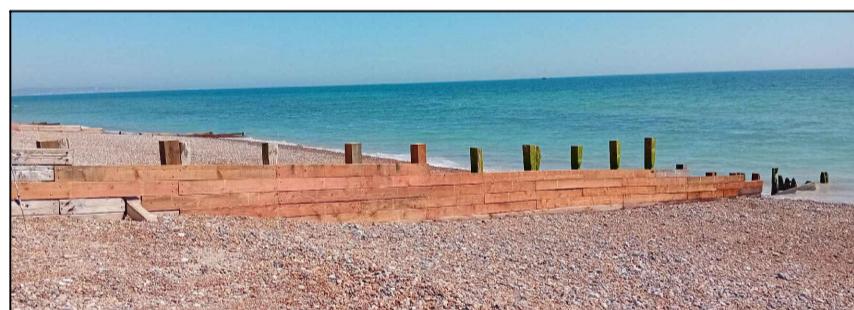
Photo of the same groyne immediately after the works were completed

The snapped piles have been extended/strengthened and the missing planks have been replaced. The shingle will naturally build up against the groyne.

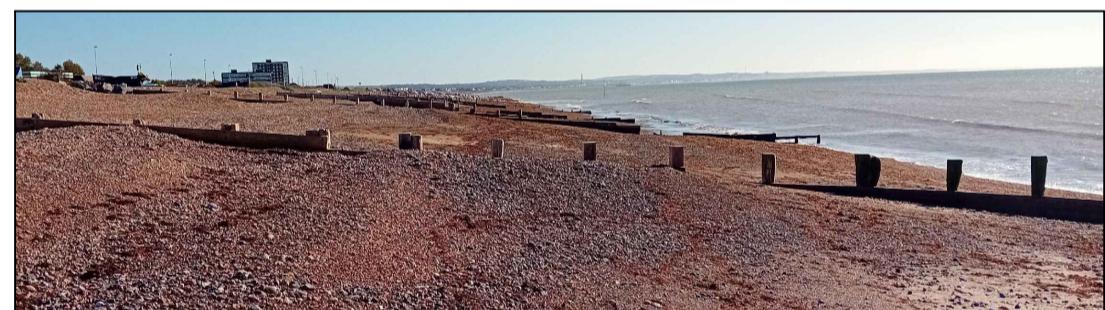
Photo of the same groyne two months after the works were completed

The shingle has naturally built up against the timber groyne. In the space of only two months the sea defence is back to its original condition.

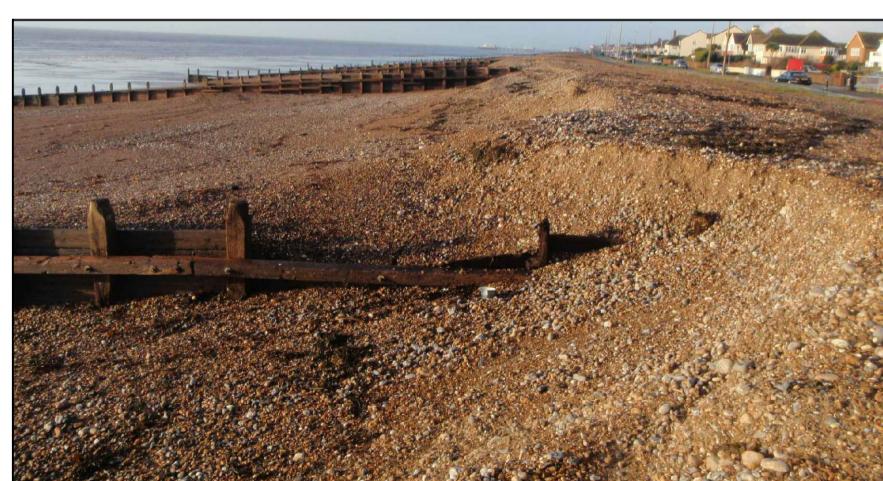
Photo of a groyne before works

The existing piles and planks at the landward end are completely rotten. During a storm the waves have washed away the timbers and eroded the beach as there is no structure to retain the shingle. This process is called outflanking.

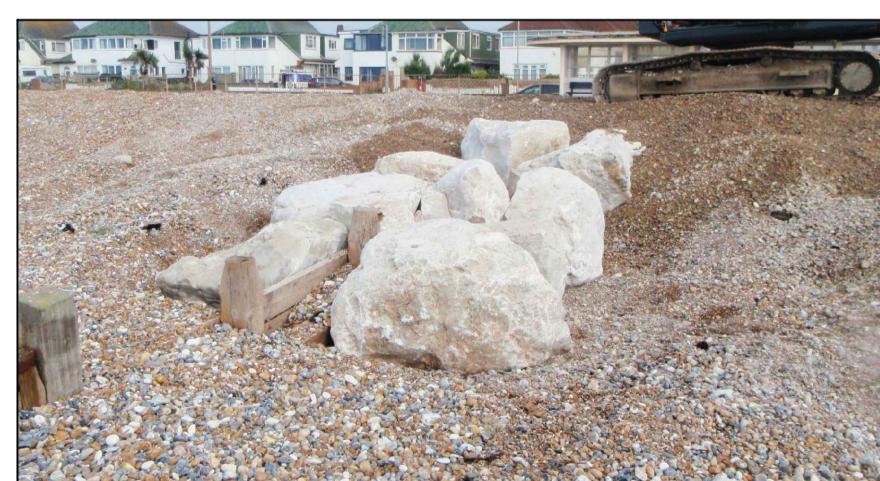
Photo of the same groyne once the rocks have been placed

Large limestone/granite rocks have been placed where the groyne was rotten. This will prevent outflanking during a storm. Once the rocks are positioned they are covered with shingle.

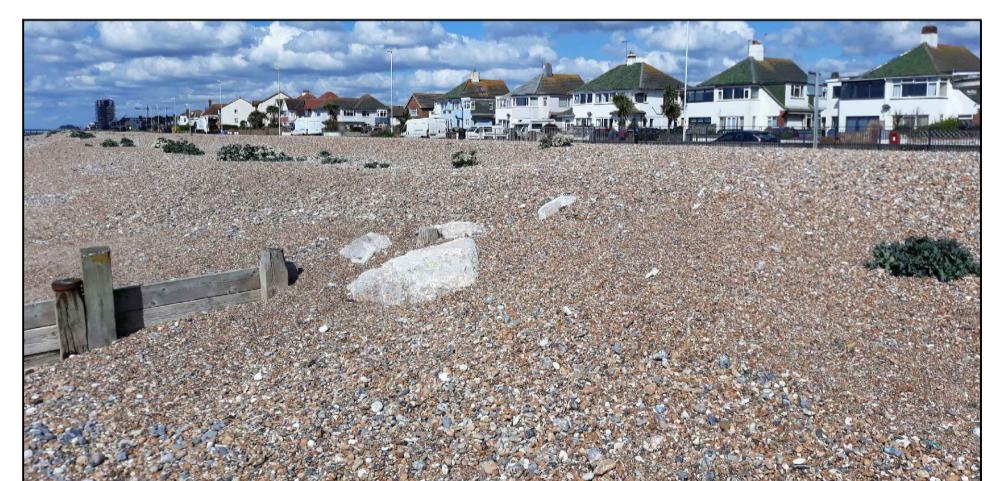
Photo of the same groyne five years after the works were completed

The same groyne five years later showing a nice stable shingle beach. Only a few of the rocks are visible.
