# Phase 1 - Timber Groyne Repairs - Works Area 7

The above plan shows the area where the contractor will be undertaking the timber groyne repairs.

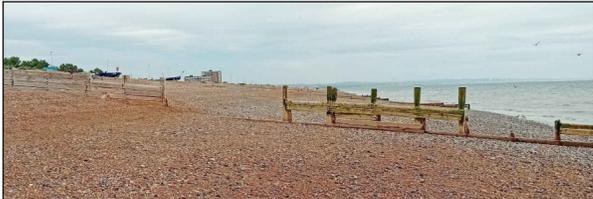
Photo of a groyne before works

The existing piles have snapped and the missing planks cannot be replaced. This has resulted in the shingle passing through the groyne and allowing the shingle beach and defence to erode.

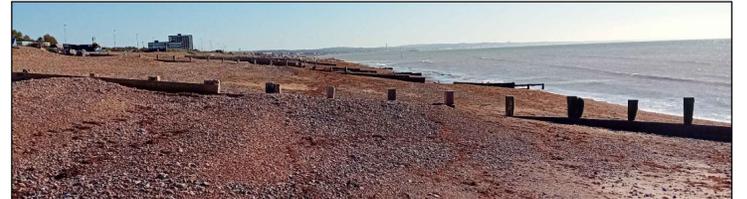
Photo of the same groyne two months after the works were completed

The shingle has naturally built up against the timber groyne. In the space of only two months the sea defence is back to its original condition.

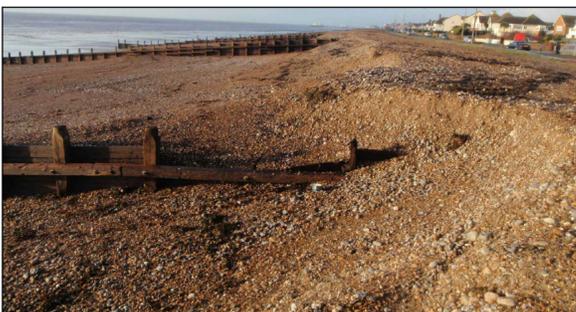
Photo of a groyne before works

The existing piles and planks at the landward end are completely rotten. During a storm the waves have washed away the timbers and eroded the beach as there is no structure to retain the shingle. This process is called outflanking.

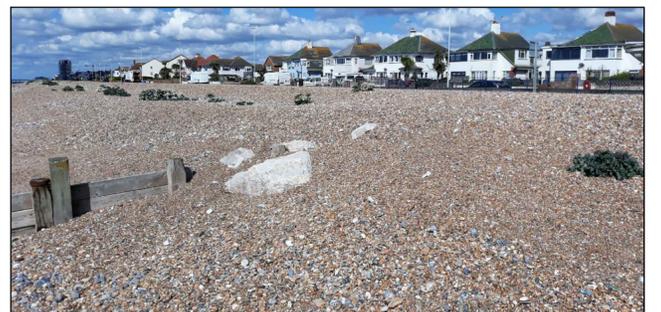
Photo of the same groyne five years after the works were completed

The same groyne five years later showing a nice stable shingle beach. Only a few of the rocks are visible.
