Phase 1 - Timber Groyne Repairs - Works Area 9

Examples of the types of repair work which will be undertaken within this area

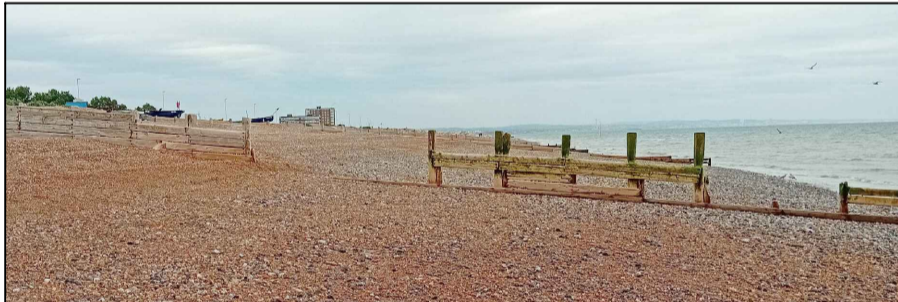
Photo of a groyne before works

The existing piles have snapped and the missing planks cannot be replaced. This has resulted in the shingle passing through the groyne and allowing the shingle beach and defence to erode.

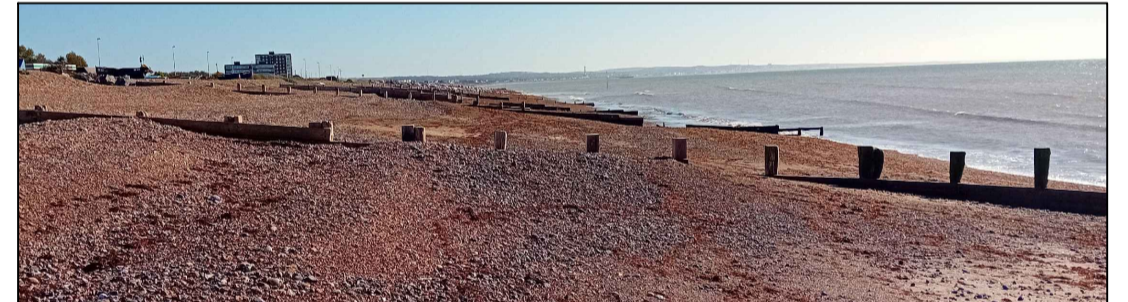
Photo of the same groyne two months after the works were completed

The shingle has naturally built up against the timber groyne. In the space of only two months the sea defence is back to its original condition.

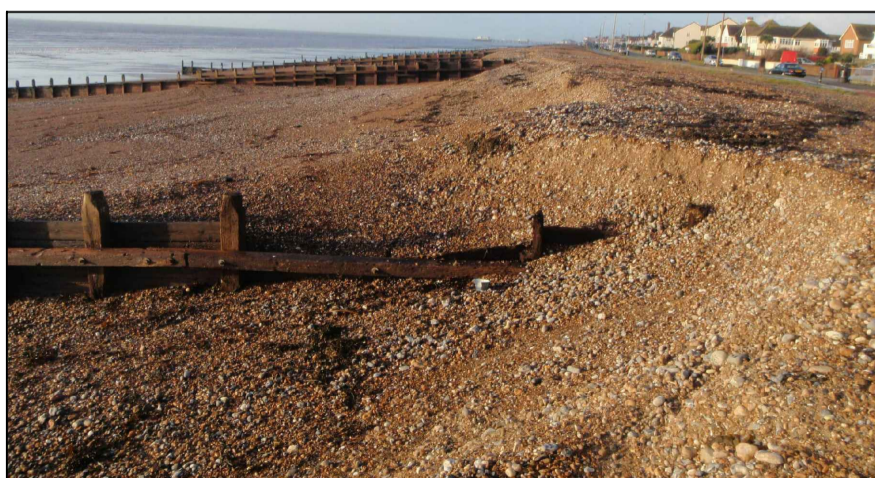
Photo of a groyne before works

The existing piles and planks at the landward end are completely rotten. During a storm the waves have washed away the timbers and eroded the beach as there is no structure to retain the shingle. This process is called outflanking.

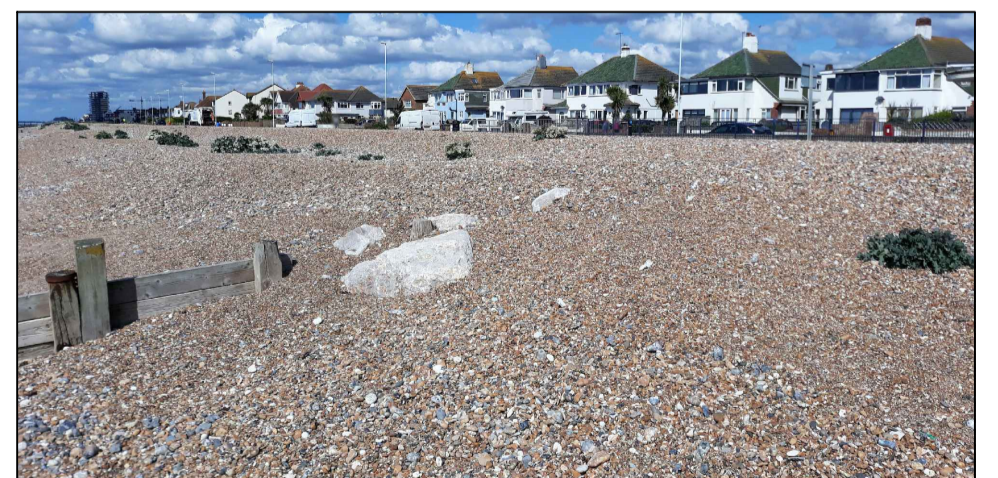
Photo of the same groyne five years after the works were completed

The same groyne five years later showing a nice stable shingle beach. Only a few of the rocks are visible.
