# Phase 1 - Timber Groyne Repairs - Works Area 10

## Examples of the types of repair work which will be undertaken within this area

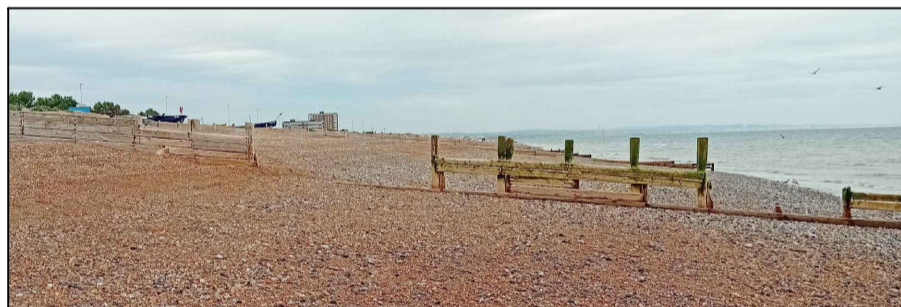
Photo of a groyne before works

The existing piles have snapped and the missing planks cannot be replaced. This has resulted in the shingle passing through the groyne and allowing the shingle beach and defence to erode.

The timber groynes will be repaired by extending the snapped timber piles and replacing the missing planks.

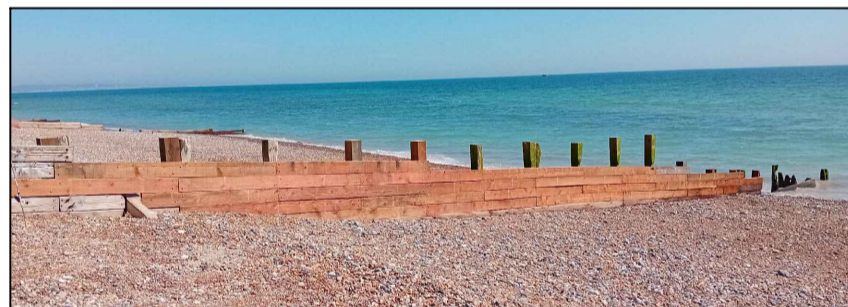
Photo of the same groyne immediately after the works were completed

The snapped piles have been extended/strengthened and the missing planks have been replaced. The shingle will naturally build up against the groyne.

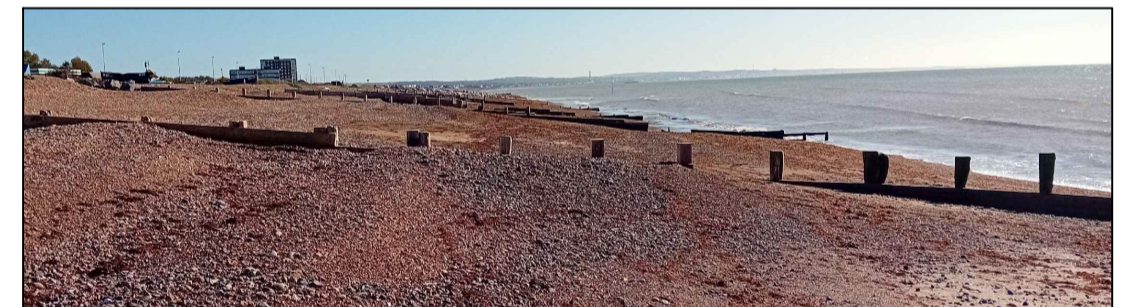
Photo of the same groyne two months after the works were completed

The shingle has naturally built up against the timber groyne. In the space of only two months the sea defence is back to its original condition.

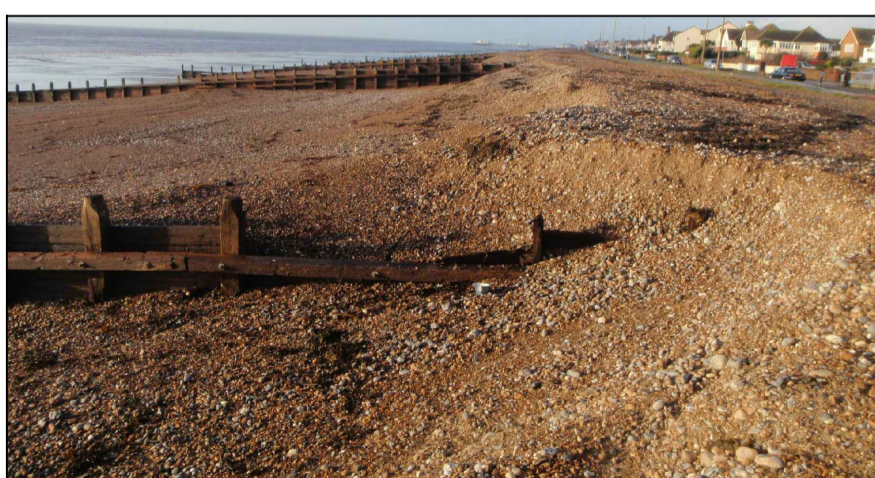
Photo of a groyne before works

The existing piles and planks at the landward end are completely rotten. During a storm the waves have washed away the timbers and eroded the beach as there is no structure to retain the shingle. This process is called outflanking.

Rocks will be placed at the northern end of some of the groynes where the timber is completely rotten.

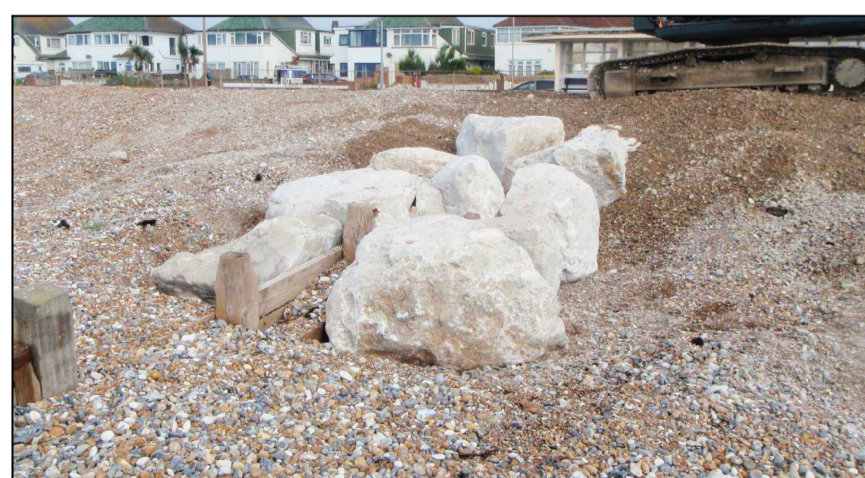
Photo of the same groyne once the rocks have been placed

Large limestone/granite rocks have been placed where the groyne was rotten. This will prevent outflanking during a storm. Once the rocks are positioned they are covered with shingle.

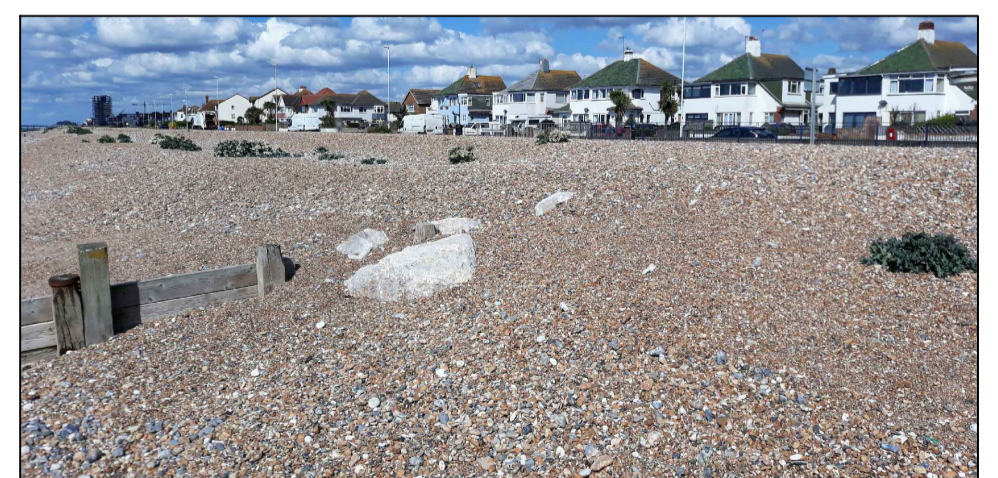
Photo of the same groyne five years after the works were completed

The same groyne five years later showing a nice stable shingle beach. Only a few of the rocks are visible.
