Final Technical Report

Lancing Surface Water Management Plan

Prepared for
West Sussex County Council

September 2015

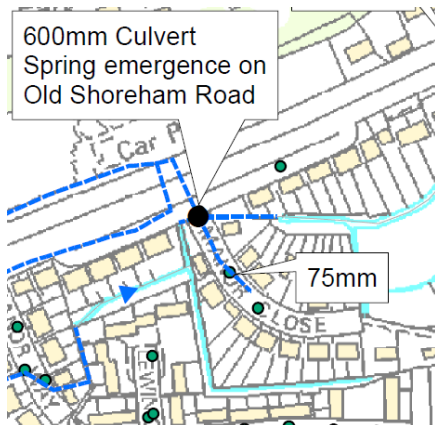
Figure 5-2 Drainage layout on Manor Close by 0.5m deep and 1.5m wide by 0.5m deep.

The upstream network discharges into the 'doctors ditch'. This ditch network is initially very constrained but widens further downstream. The ditch then enters a culvert to pass under Manor Close, which has a 450mm opening. During the site visit in October 2014 the manhole in Manor Close was lifted to confirm the location of the culvert. The main line of the culvert passed through the manhole in a 600mm diameter pipe (NB: the manhole was heavily silted). There was an additional pipe entering from the north (which is the overflow pipe from Manor Road system and discharge location from the A27) and a minor 75mm diameter pipe entering from the south (see Figure 5-2). The culvert emerges behind houses on Manor Close and Old Shoreham Road. The ditch in this location varied between 0.5m wide

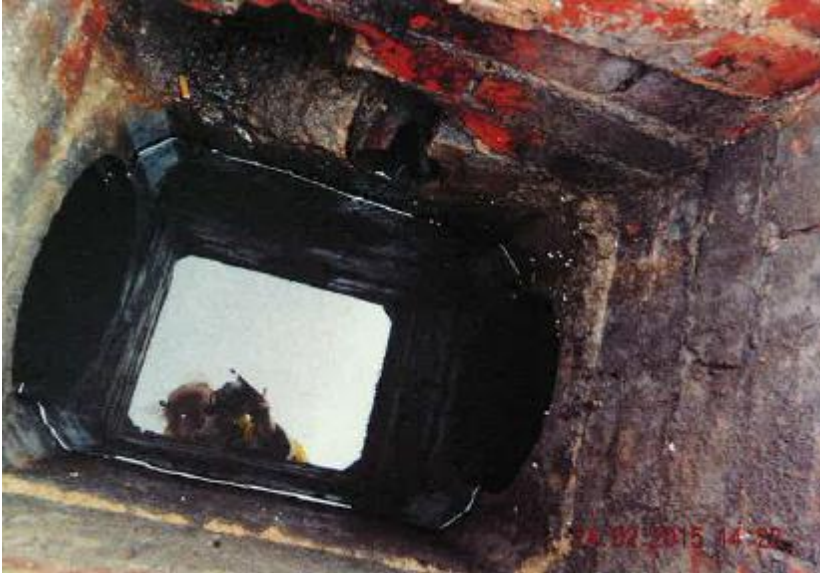
Throughout the estate the condition and silt levels in the pipe network varies. On Bristol Avenue and George V Avenue the pipes there was little evidence of silt (October 2014). Along The Westway some pipes were clear and some were almost up to 50% silted, particularly on the far east of the estate. Road gullies were in bad condition throughout, approximately 10% were completely cracked/broken, 10-20% were choked (full of sediment) and a further 30% had standing water (although it had been raining heavily the day before the site visit in October 2014).

Figure 5-4 Photo of manhole on A259 (taken by WSCC)

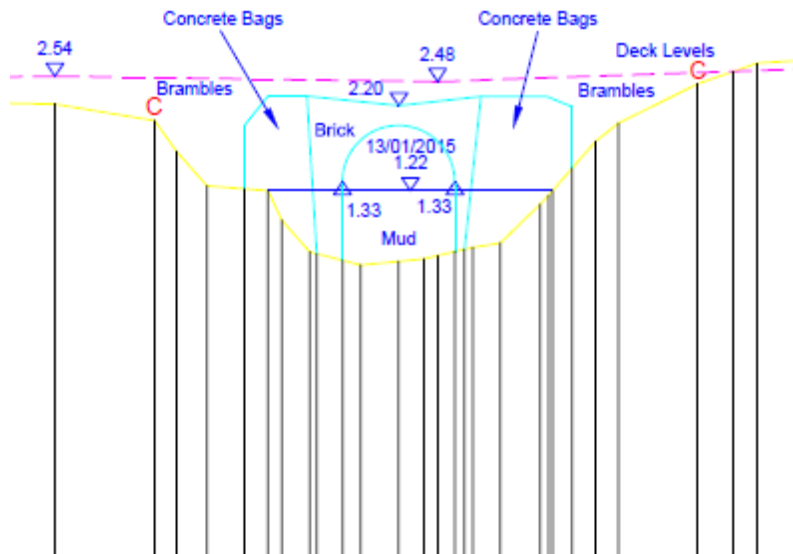
Honeyman's Hole is a spring located immediately south of the A27 (co-ordinates 519088, 105881). It is not possible to quantify its contribution of flow to the Lancing Brooks with any certainty, but it flows all year round. Honeyman's Hole discharges into a ditch network which runs both east towards a sluice gate into the tidal Adur, and south into a culvert which runs under Shoreham Airport (via a large brick arch culvert²⁶, as shown in Figure 5-7). During low tide approximately 50% of flows from Honeyman's Hole drains towards the sluice gate, with the remainder flowing south. During tide-lock situations all flows from Honeyman's Hole will flow south towards the brick arch culvert.

Figure 5-7 Culvert under Shoreham Airport from Honeyman's Hole (from Cross-Section Survey)

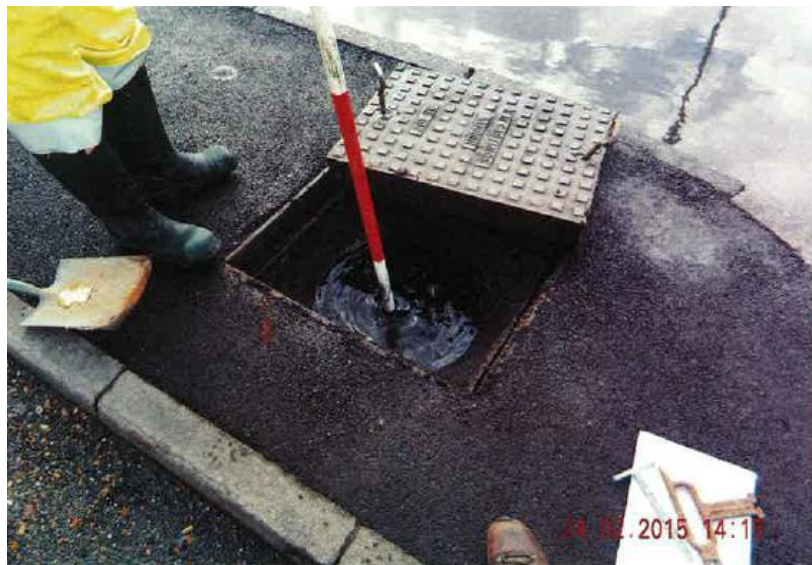
In addition to the quick win measures, additional capital works may be required to alleviate flooding on The Broadway, which is the most persistent flooding problem affecting the Estate. Evidence from surveys undertaken by WSCC in February 2015 demonstrates that the two existing soakaways on The Broadway can become full of water following heavy rainfall, during winter months when groundwater levels are high, and/or during high tides (which can push groundwater towards the surface). As gullies on The Broadway are connected to the two existing soakaways there is no capacity for water to drain away from the gullies during rainfall events, which will therefore contribute towards

Figure 8-2 Photo of soakaway near the shops on The Broadway

flooding on The Broadway. To alleviate this flooding, a proposed option has been considered as part of the SWMP, which is described below. Conceptual drawings of these options are provided in Appendix H. Options which have been discounted are shown in Table 8-1.
