Phase 1 - Timber Groyne Repairs - Works Area 2

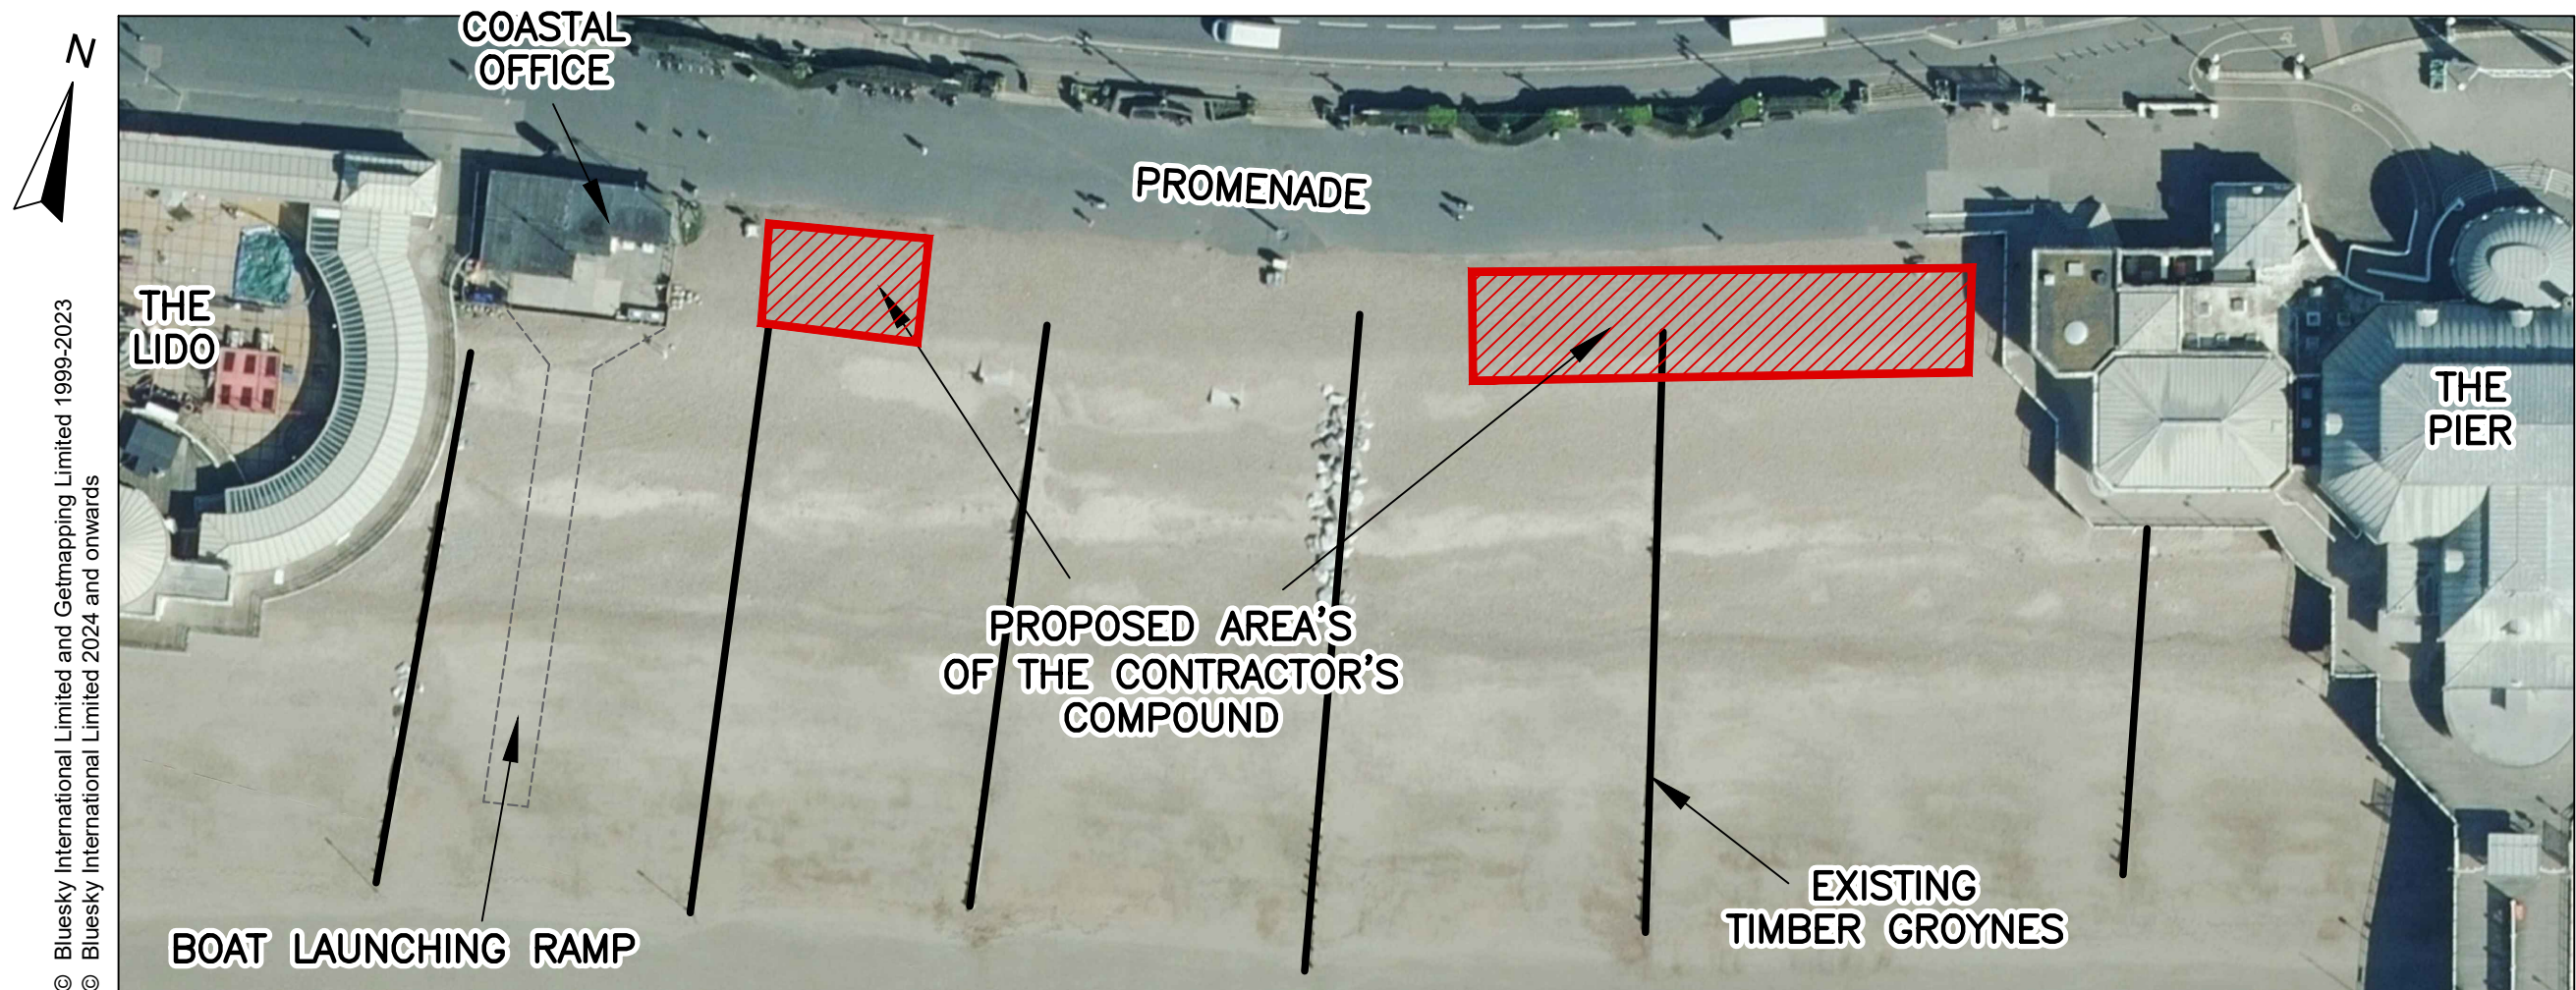
The above plan shows the area where the contractor will be undertaking the timber groyne repairs.

The timber groynes will be repaired by extending the snapped timber piles and replacing the missing planks. Rocks will be placed at the northern end of some of the groynes where the timber is completely rotten. These types of repairs have already been undertaken to other timber groynes within Worthing.

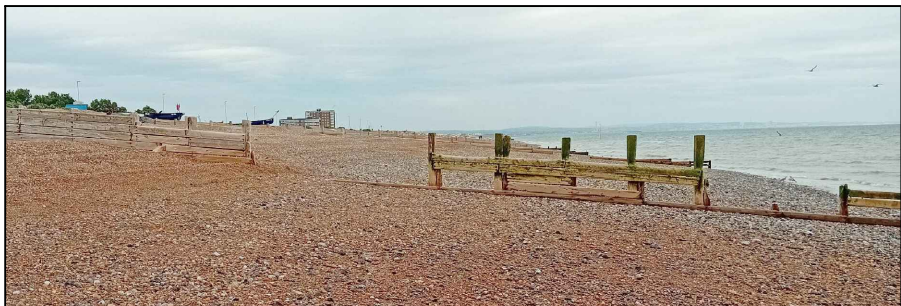
Photo of a groyne before works

The existing piles have snapped and the missing planks cannot be replaced. This has resulted in the shingle passing through the groyne and allowing the shingle beach and defence to erode.

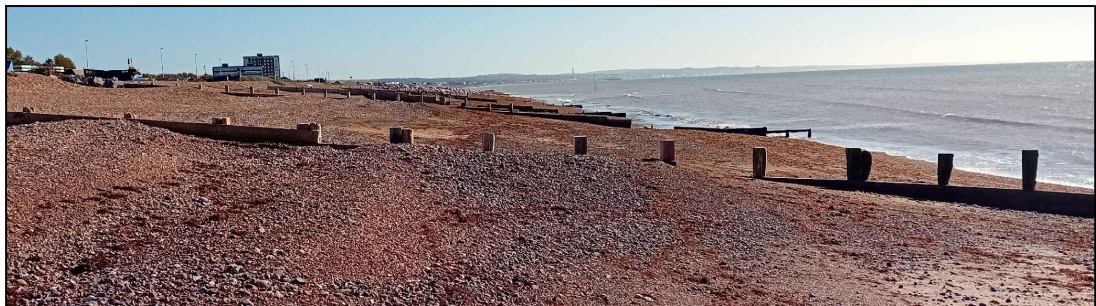
Photo of the same groyne two months after the works were completed

The shingle has naturally built up against the timber groyne. In the space of only two months the sea defence is back to its original condition.

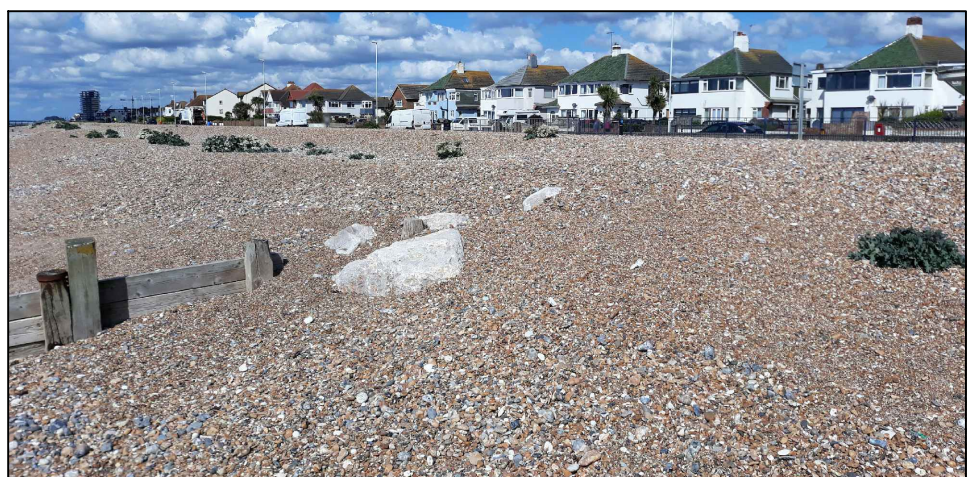
Photo of the same groyne five years after the works were completed

The same groyne five years later showing a nice stable shingle beach. Only a few of the rocks are visible.
