# Phase 1 - Timber Groyne Repairs - Works Area 3

## Examples of the types of repair work which will be undertaken within this area

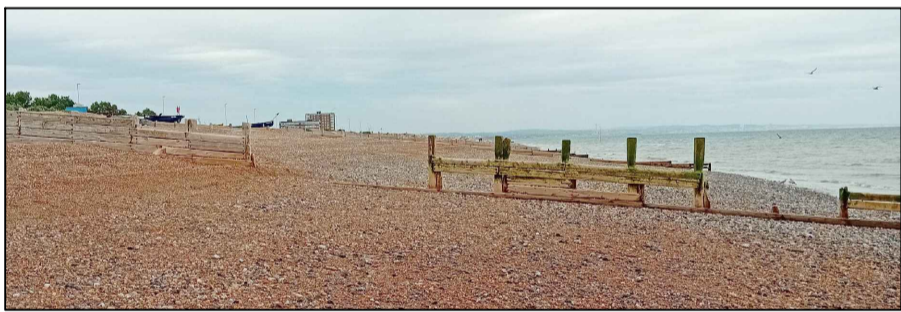
Photo of a groyne before works

The existing piles have snapped and the missing planks cannot be replaced. This has resulted in the shingle passing through the groyne and allowing the shingle beach and defence to erode.

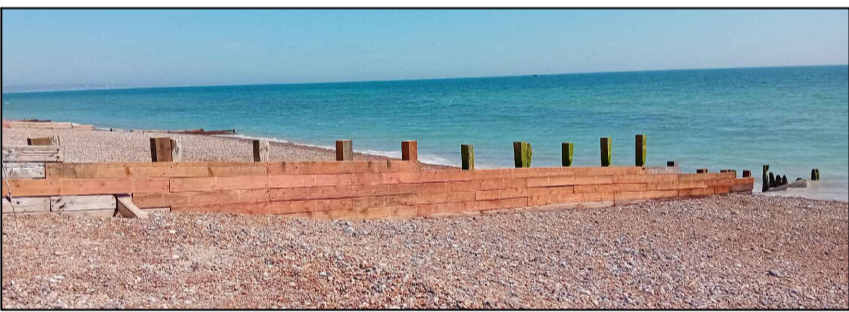
Photo of the same groyne immediately after the works were completed

The snapped piles have been extended/strengthened and the missing planks have been replaced. The shingle will naturally build up against the groyne.

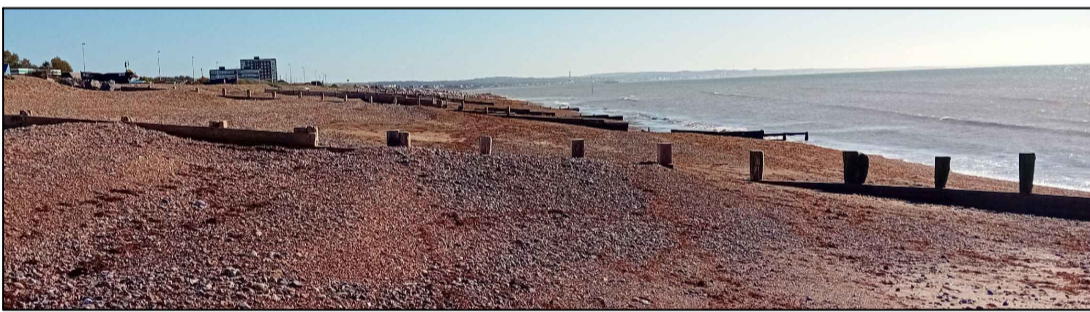
Photo of the same groyne two months after the works were completed

The shingle has naturally built up against the timber groyne. In the space of only two months the sea defence is back to its original condition.

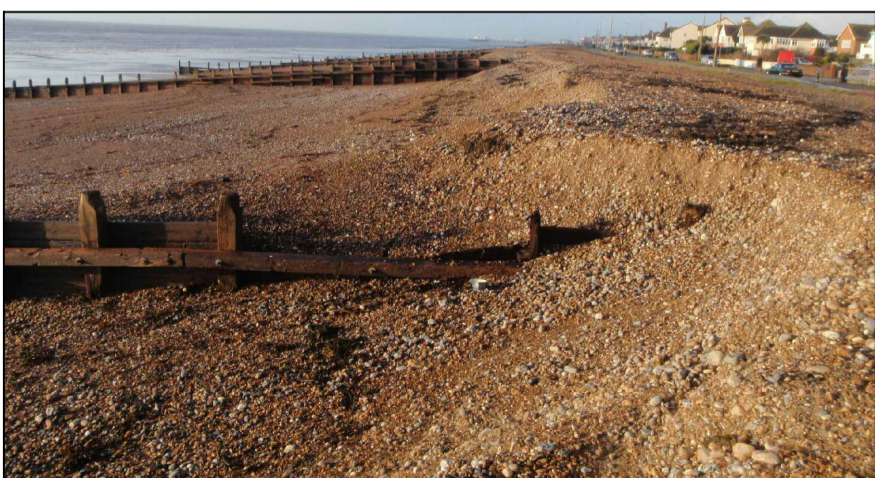
Photo of a groyne before works

The existing piles and planks at the landward end are completely rotten. During a storm the waves have washed away the timbers and eroded the beach as there is no structure to retain the shingle. This process is called outflanking.

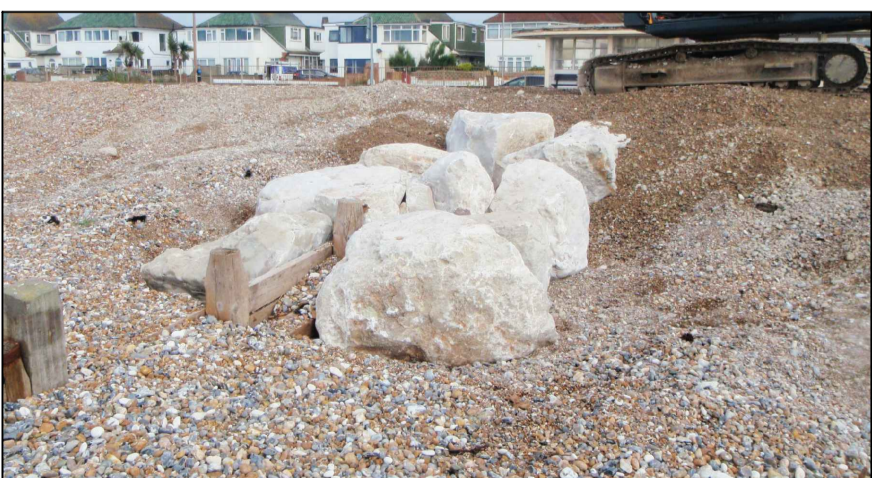
Photo of the same groyne once the rocks have been placed

Large limestone/granite rocks have been placed where the groyne was rotten. This will prevent outflanking during a storm. Once the rocks are positioned they are covered with shingle.

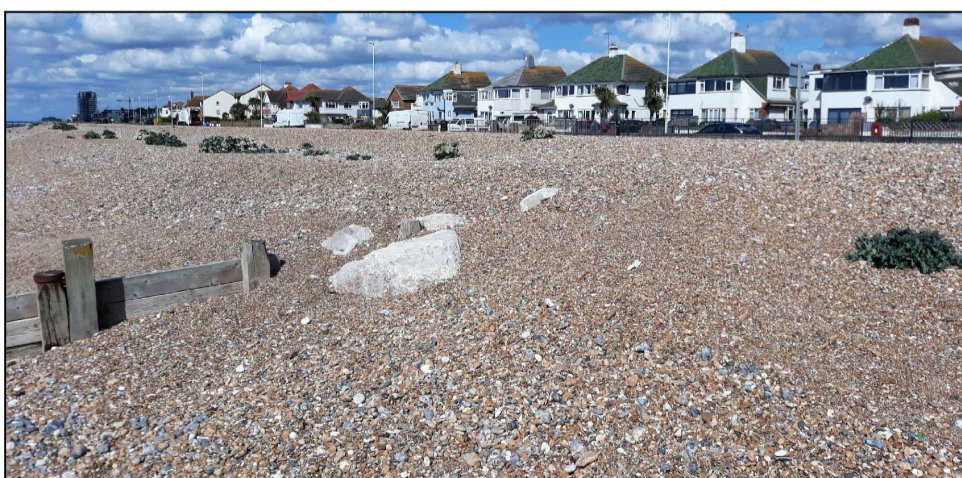
Photo of the same groyne five years after the works were completed

The same groyne five years later showing a nice stable shingle beach. Only a few of the rocks are visible.
