# Phase 1 - Timber Groyne Repairs - Works Area 4

## Examples of the types of repair work which will be undertaken within this area

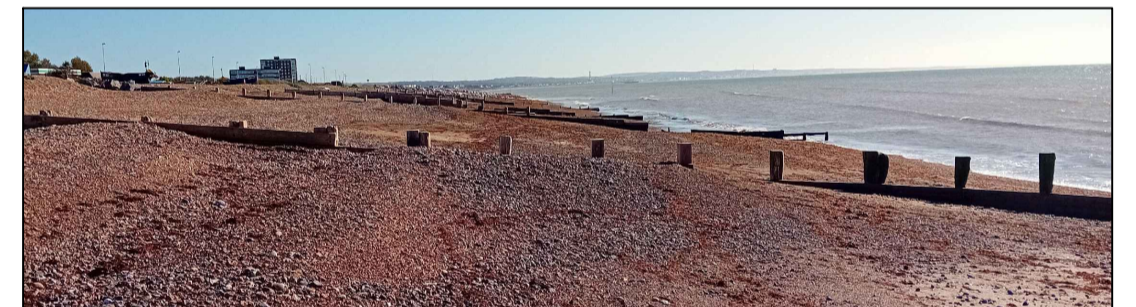
Photo of the same groyne two months after the works were completed

The shingle has naturally built up against the timber groyne. In the space of only two months the sea defence is back to its original condition.

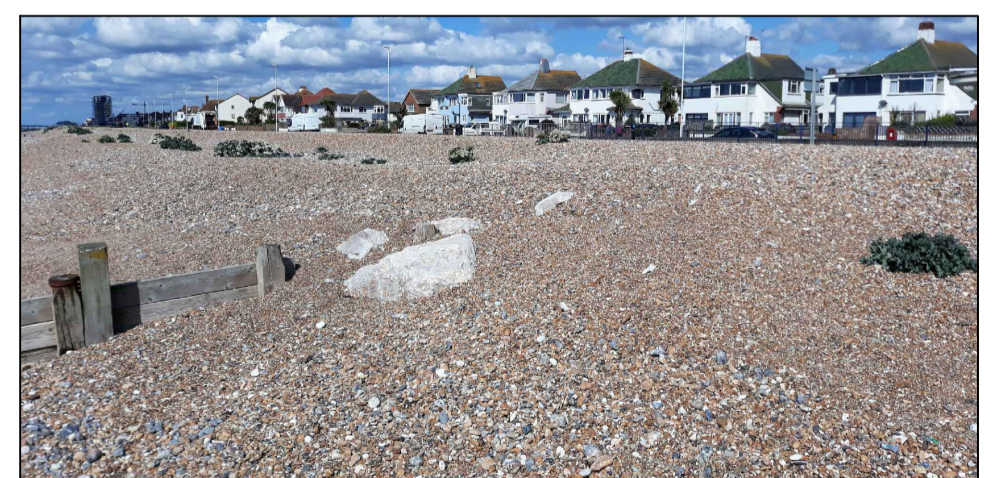
Photo of the same groyne five years after the works were completed

The same groyne five years later showing a nice stable shingle beach. Only a few of the rocks are visible.
