Phase 1 - Timber Groyne Repairs - Works Area 8

Examples of the types of repair work which will be undertaken within this area

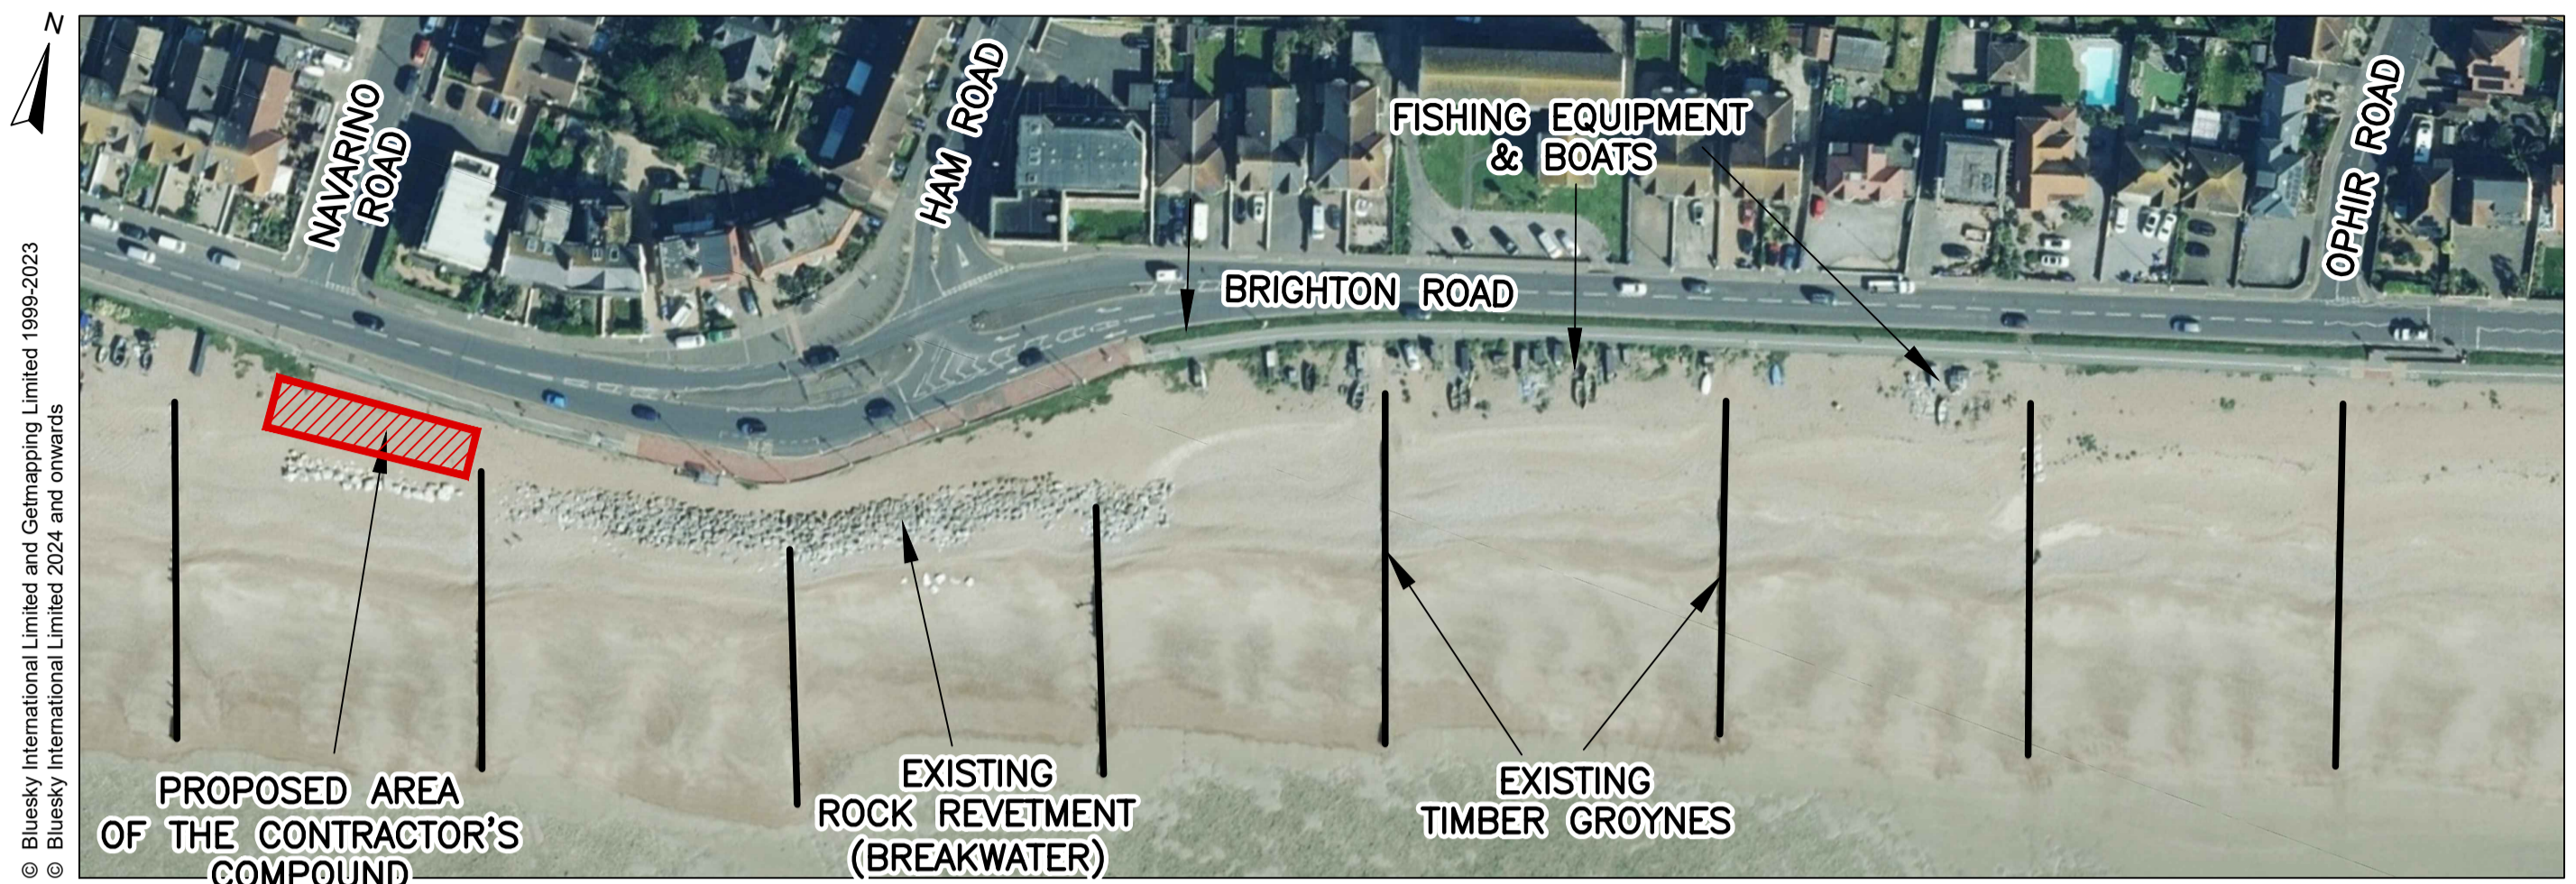
The above plan shows the area where the contractor will be undertaking the timber groyne repairs.

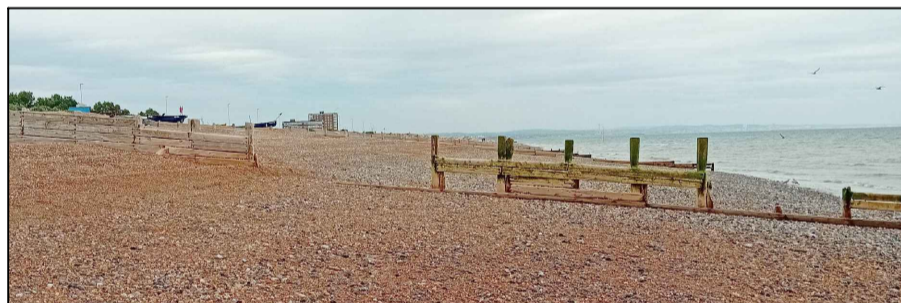
Photo of a groyne before works

The existing piles have snapped and the missing planks cannot be replaced. This has resulted in the shingle passing through the groyne and allowing the shingle beach and defence to erode.

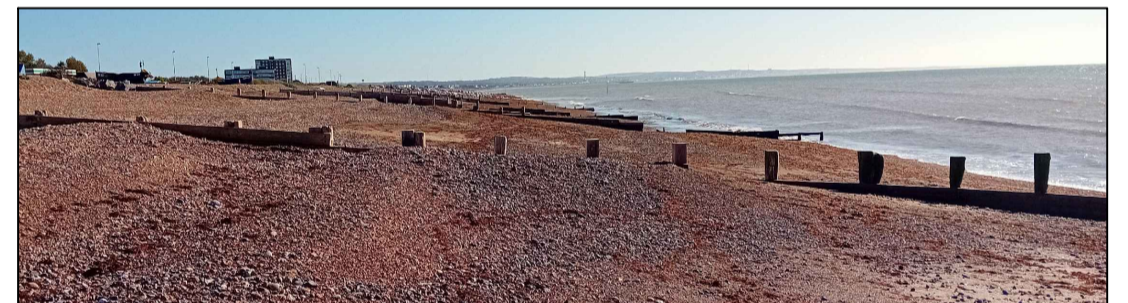
Photo of the same groyne two months after the works were completed

The shingle has naturally built up against the timber groyne. In the space of only two months the sea defence is back to its original condition.

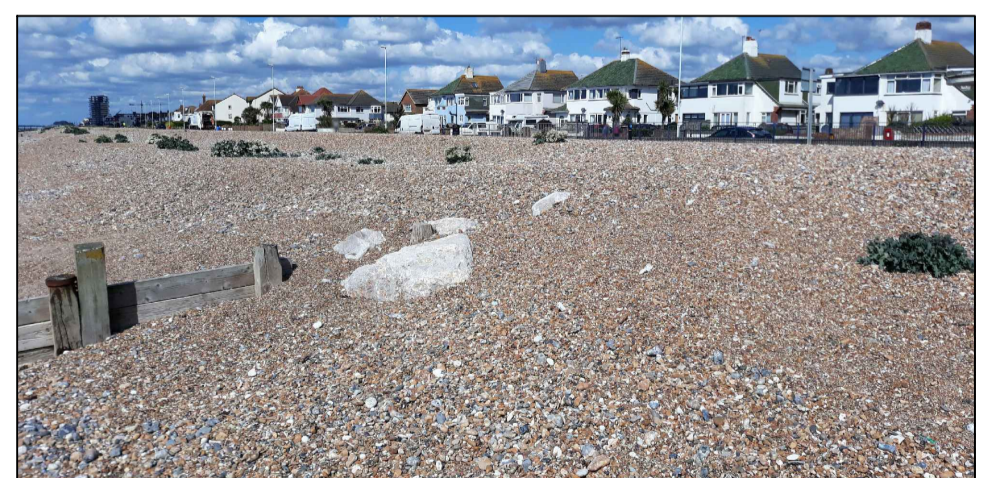
Photo of the same groyne five years after the works were completed

The same groyne five years later showing a nice stable shingle beach. Only a few of the rocks are visible.
