I.0 Goring Hall Conservation Area: An Overview

Goring Hall Summary of Significance

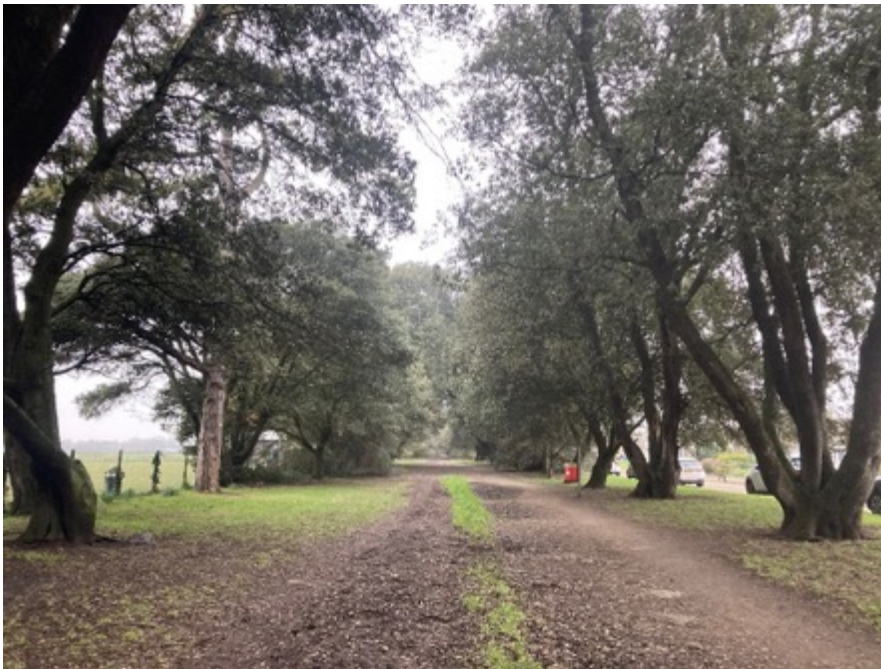
Figure 12: Ilex Avenue facing west

- 4.4 The Ilex Avenue is a key aspect of the landscape character of the conservation area. This was a designed Avenue to provide access to Goring Hall from Ferring in the west and Worthing in the east. Although some of the trees had to be replaced following the Great Storm of 1987, the majority of trees are mature in appearance and provide an enclosed walkway with glimpses over the open fields to the sea beyond.

- 6.4 The Ilex Avenue is an important route through the conservation area, but a lack of proper management has led the track to become worn. The loss of the former grass verges and the lack of pruning of the trees has resulted in a dark enclosed space with limited views to the sea when facing south and has altered its historic character.

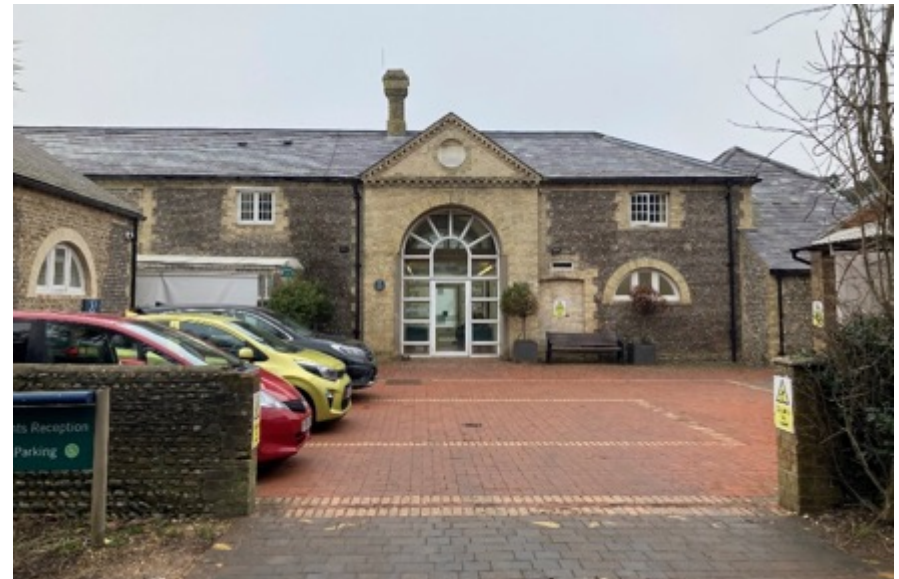
Figure 13: Former Stable building to Goring Hall (listed grade II)

- 4.13 Within the grounds of Goring Hall there are a number of outbuildings which relate to the historic running of the house. The historic stable block (listed grade II) to the north of the hall (and now attached via a modern extension) is a brick and flint building similar to the other historic structures within the grounds. These reflect the materials found within the local area. The flint walls that enclose the grounds, service areas and walled garden are all reflective of boundary treatments within the conservation area and wider locale.

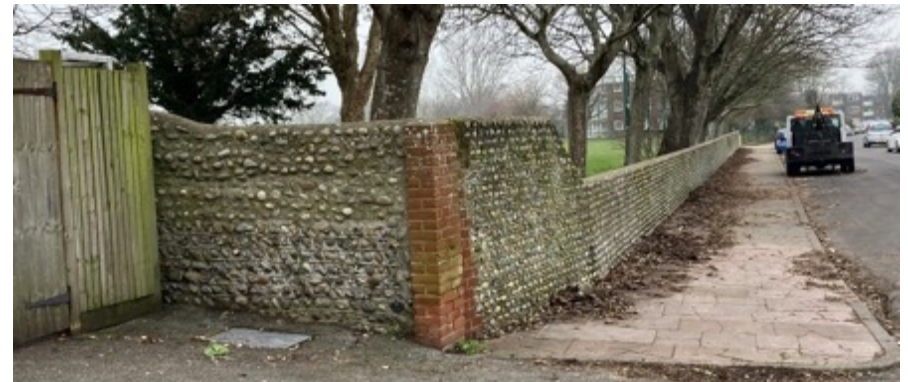
Figure 17: Flint wall to the north of The Bull's Head within the conservation area.

- 4.19 The Bull's Head and the flint wall to the north marks the northern extent of the conservation area. This building has entrances on Goring Street and can be accessed off Fernhurst Drive. The Bull's Head is surrounded by areas of hardstanding, in contrast to the more verdant character found elsewhere within the conservation area. To the west (rear) of the building there is a beer garden which reflects the green character of the area with mature trees and open space, but to the front of the public house the carpark provides a large area of hardstanding that detracts from its setting. A flint boundary wall runs to the north of The Bull's Head alongside the pavement of Goring Street and is another example of this type of boundary treatment that is seen throughout the local area.

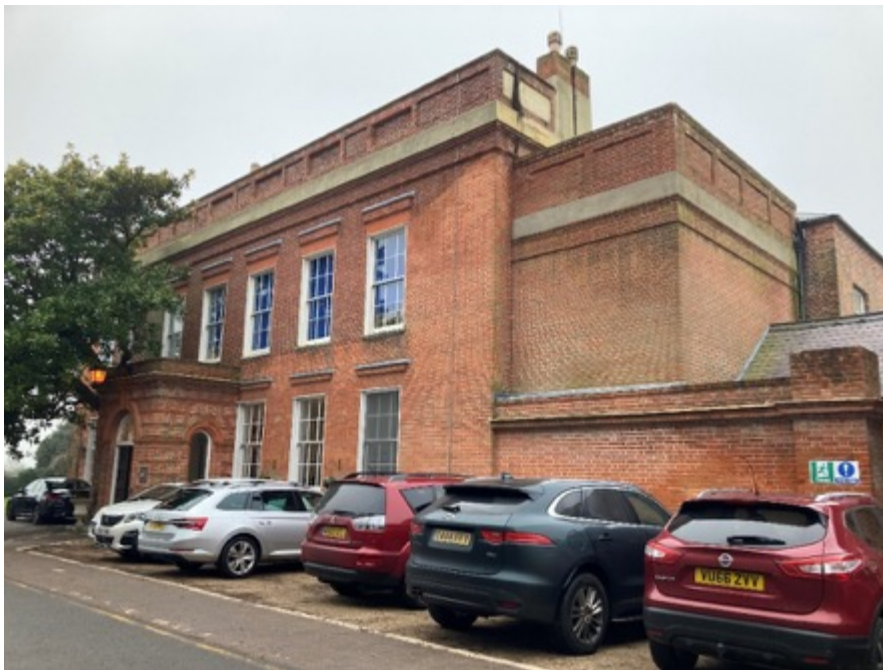
Figure 20: East facing elevation of Goring Hall with parking to front

built in the Queen Anne style, in contrast to the more neo-classical appearance of the original building which was rendered. It has been altered and extended in the 20th century, but retains a sense of the original building. Although not the oldest building within the conservation area (The Bull's Head has 16th century elements behind an 18th century façade), it is the grandest. The building is set within substantial grounds and the remaining service buildings in flint and yellow brick also contribute to the architectural interest of the conservation area. The flint buildings in particular are characteristic of the vernacular tradition of the locale.

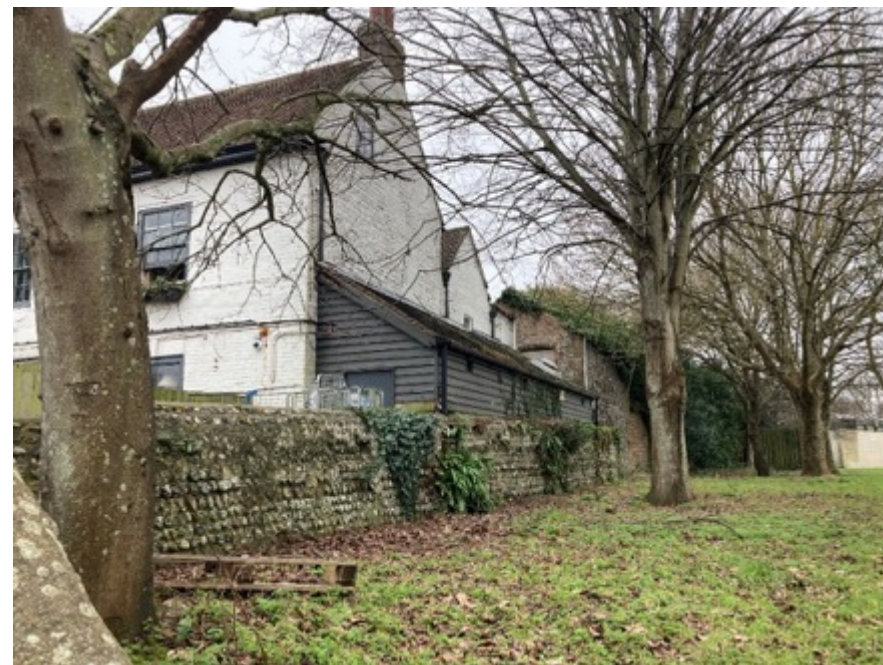
Figure 23: Examples of brick, flint and weatherboarding on and next to The Bull's Head.

4.32 Elsewhere, The Bull's Head comprises a number of building materials, reflecting its continuous development. The materials include painted brickwork, coursed flint walls, render with red brick window dressings and weatherboarding. There is one modern building adjacent to North Lodge

which utilises random stone rubble for the external chimney breast and porch. Roofing materials are a mixture of clay and slate.

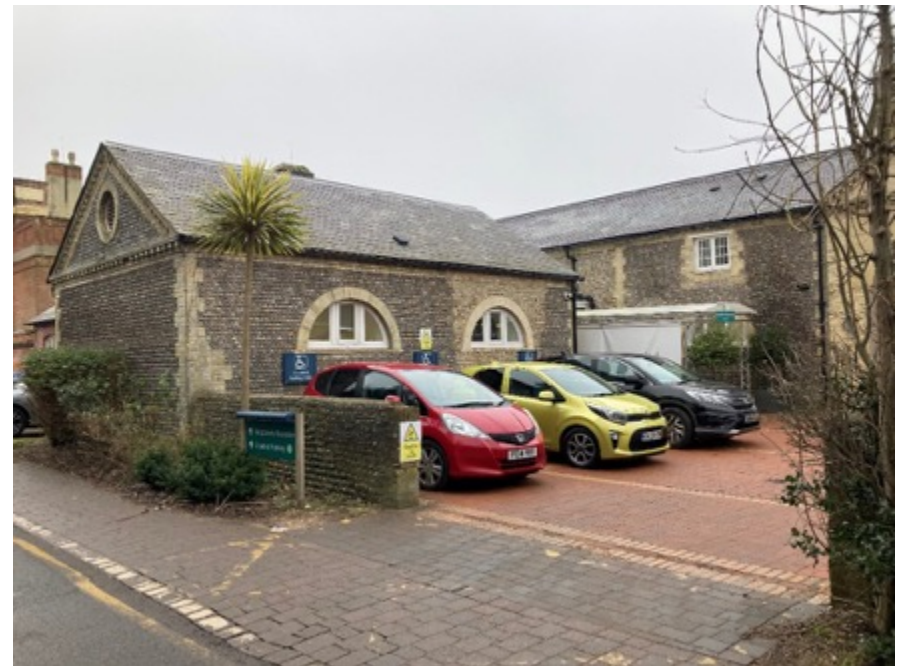
Figure 26: Examples of paving treatments in Goring Hall grounds.

- 4.33 The unifying feature of the conservation area are the extensive flint boundary walls, which surround the historic Goring Hall estate and the land to the north of The Bull's Head. The flint walls are not homogenous, but vary in terms of their height, intactness, quality and age. Some are built of coursed cobbled flints, while others are made of broken flints laid in a more random arrangement.
- 4.34 Roads and pavements throughout the conservation area are predominantly in modern tarmac or concrete paving slabs. The Ilex Avenue is a dirt track, closed to vehicles. The historic approach to the Goring Hall Estate from North Lodge is covered in gravel, disguising any earlier road treatment. Within Goring Hall grounds, the predominant road material is tarmac, but there are examples of brick and block paving within the historic service yard area.

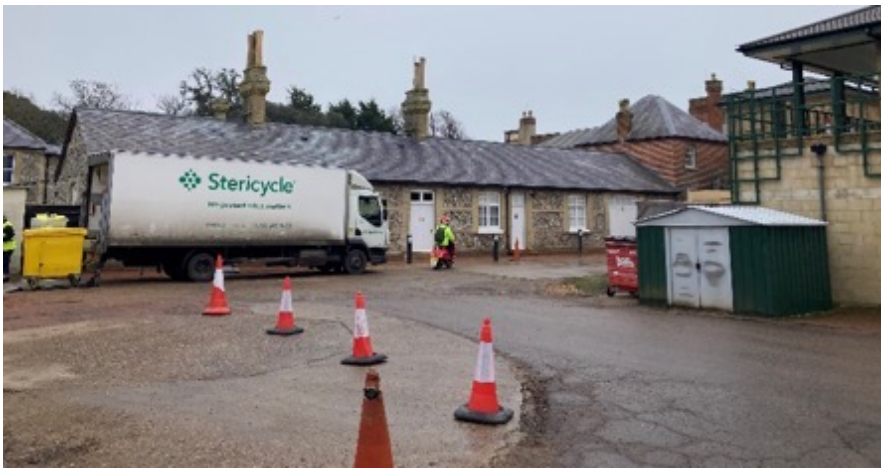
Figure 29: Extensive areas of hardstanding within the grounds of Goring Hall

- 4.40 The amount of hardstanding around Goring Hall, now used as parking space for the hospital and within the former walled orchard is a negative feature. This was originally green space associated with the hall and characteristic of a country estate that has been lost and now detracts from the green character of the conservation area.
- 4.41 Similarly, the car park outside of The Bull's Head southern facing elevation is a noticeable area of hardstanding within the conservation area, especially surrounding this historic building that detracts from its character and is an area where improvement could be made through the use of planting and soft landscaping.
