# Phase 1 - Timber Groyne Repairs - Works Area 1

## Examples of the types of repair work which will be undertaken within this area

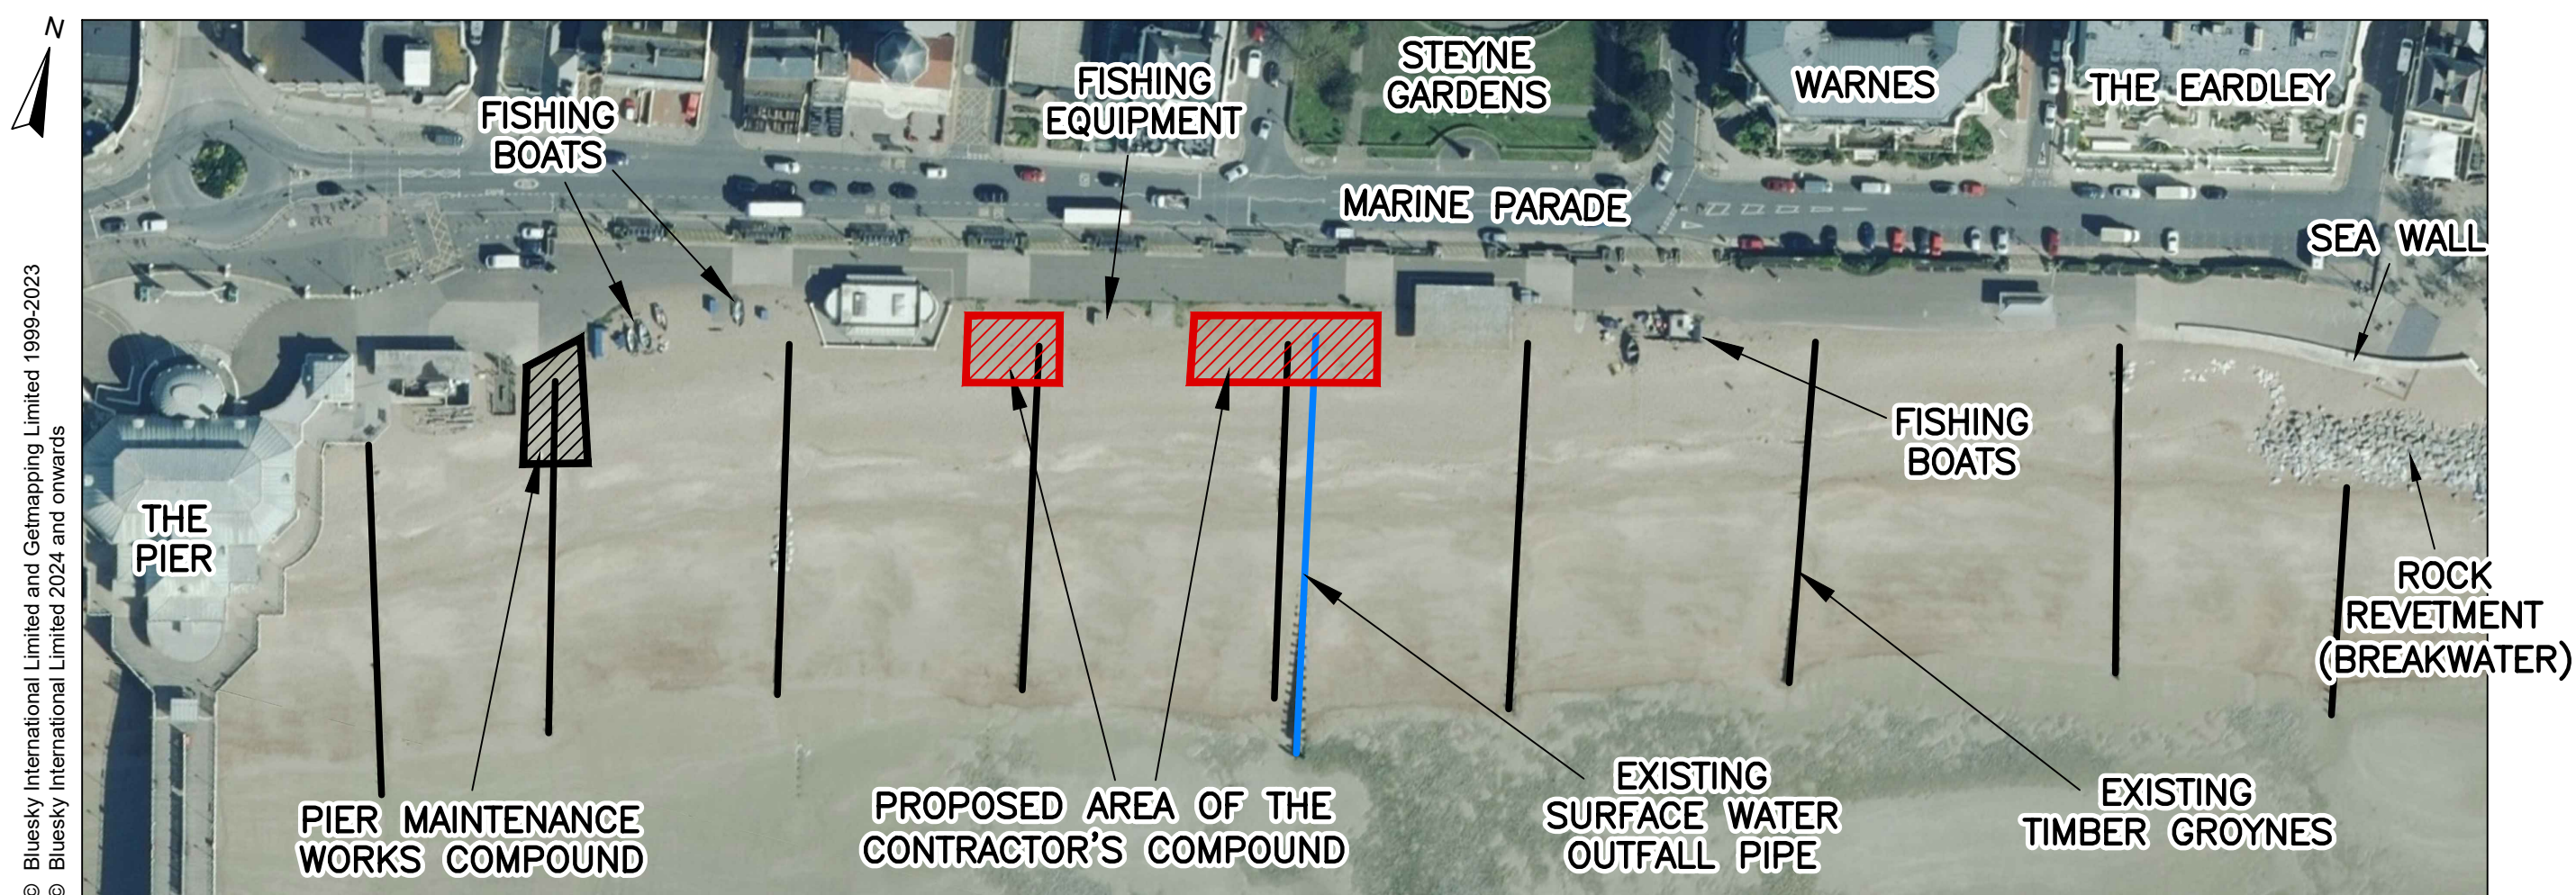
The above plan shows the area where the contractor will be undertaking the timber groyne repairs.

The timber groynes will be repaired by extending the snapped timber piles and replacing the missing planks. Rocks will be placed at the northern end of some of the groynes where the timber is completely rotten. These types of repairs have already been undertaken to other timber groynes within Worthing.
