# Phase 1 - Timber Groyne Repairs - Works Area 10

## Examples of the types of repair work which will be undertaken within this area

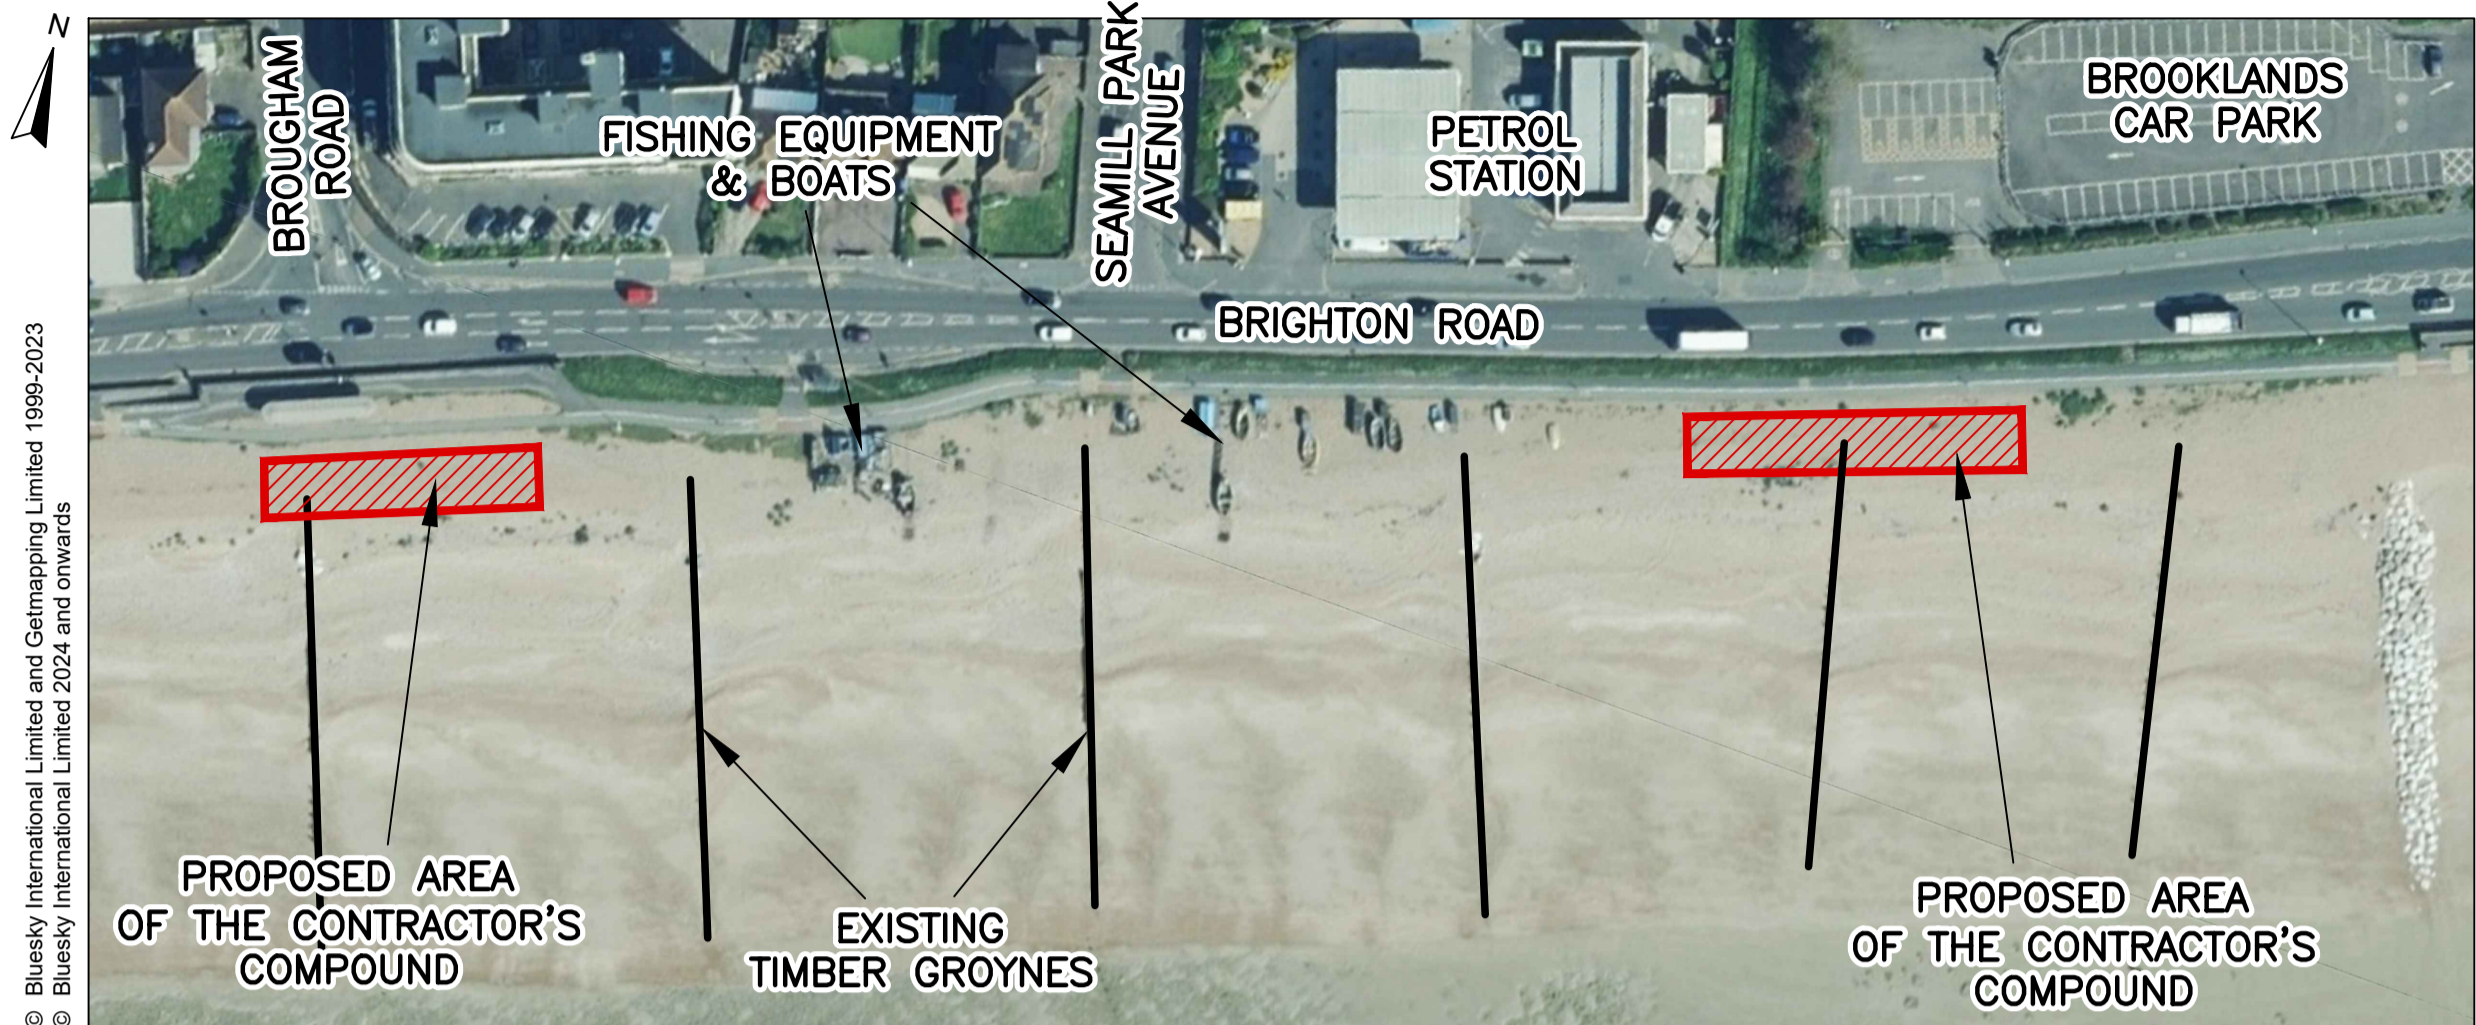
The above plan shows the area where the contractor will be undertaking the timber groyne repairs.

Worthing's primary sea defence is the shingle beach, and the timber groynes are used to control the shingle levels. Therefore not all of the timber groynes will be repaired, only those which are not retaining the shingle beach to the desired beach levels.

The timber groynes will be repaired by extending the snapped timber piles and replacing the missing planks.

Rocks will be placed at the northern end of some of the groynes where the timber is completely rotten.
