## 2.0 Historical Development

## 5.0 Assessment of condition

## 6.0 Management Plan

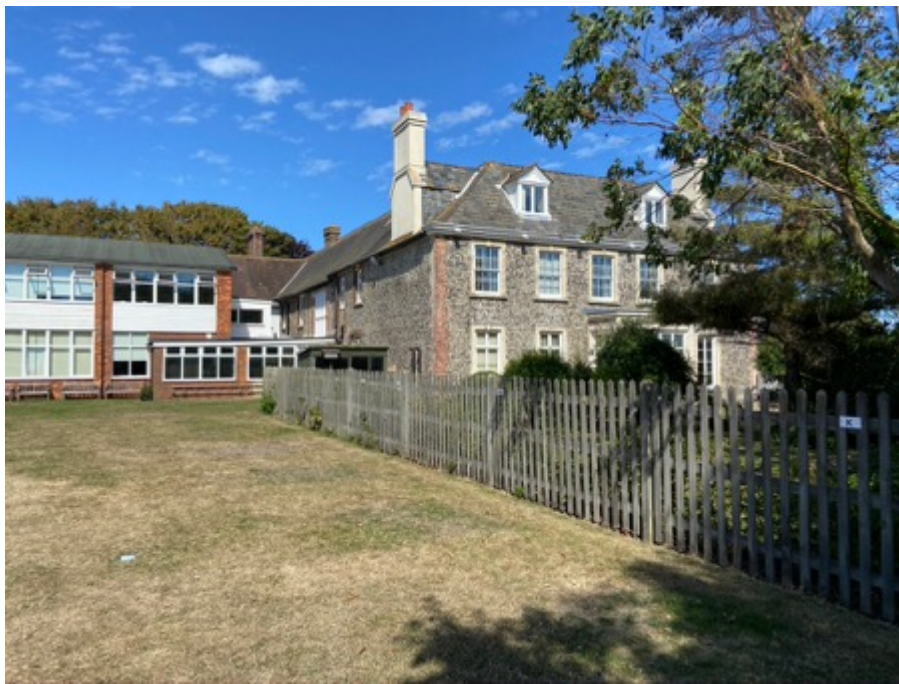
- 3.17 There is little evidence of timber framing from the external elevations of historic buildings in the conservation area, although some timber framing is likely to be concealed in parts of the Old Rectory, tithe barn and possibly the manor house. The most commonly found broken flints are known as field flints, and would have been ploughed up for use in buildings. In higher status buildings there are examples of knapped and coursed flints. Flints are used extensively in both buildings and boundary walls, as intact cobbles or field flints; the south front of the manor is of knapped and coursed flints.

Fig 14: Knapped and coursed flint, slate roof

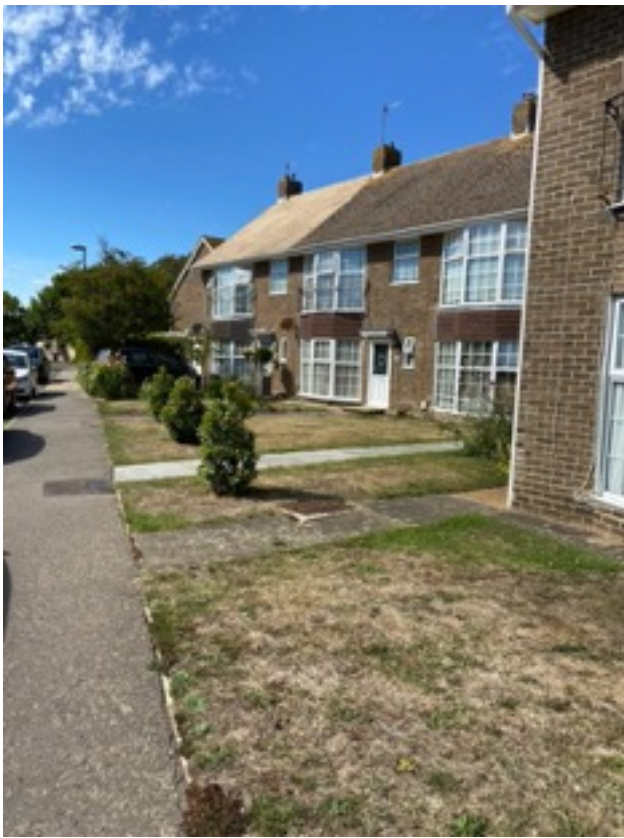
- 3.32 It is proposed to remove modern terraced housing on the north side of St Julian's Lane west of the church. These houses, while of a scale appropriate to the conservation area, are part of a much more extensive modern housing development north of St Julian's Lane and Rectory Road. The modern housing, in a mock Georgian style, makes little contribution to the character of the post medieval estate associated with the old manor house, and it is therefore proposed for exclusion here.

Fig 18: Modern housing on St Julian's Lane

6.3 Modern housing along St Julian's Lane is part of a wider housing development to the north. In a mock Georgian style, it bears no relation to the vernacular buildings in this part of the conservation area. While the scale is appropriate and individual plots are well maintained, it is difficult to justify their inclusion in the conservation area when they clearly relate to a distinct phase of redevelopment in Kingston. Spinalls Grove is proposed for removal for similar reasons.

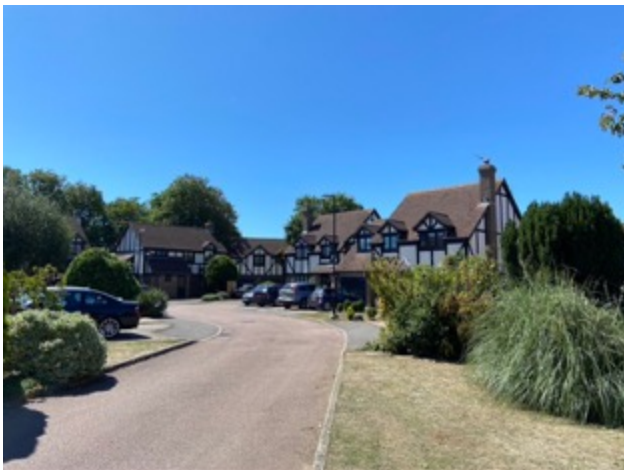
- 3.33 Finally it is proposed to remove from the conservation area the modern housing at Spinnals Grove east of Kingston Lane. These buildings were developed on previously open land shortly after the conservation area was originally designated. However, this review concludes that it as an inward

facing cul-de-sac behind a modern flint wall, it makes little contribution to the character or appearance of the conservation area, which is designated principally for its ancient manorial connections. The open land to the south currently used as croquet and tennis lawns is retained within the conservation area boundary, because of its age and historic association with the 19<sup>th</sup> and 20<sup>th</sup> century growth of Kingston, and because of the contribution the open space makes in views within the conservation area.

Fig 19: Modern housing at Spinnals Grove

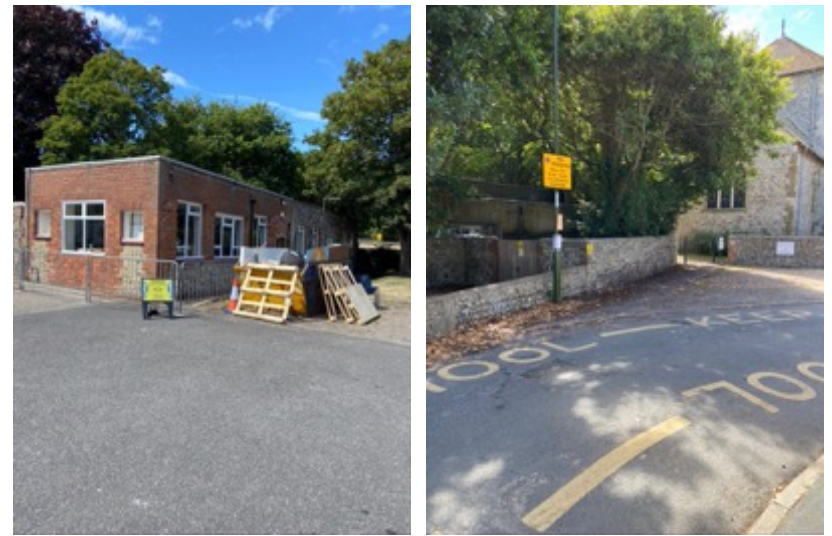
- 3.34 Two further buildings have been identified as negative contributors to the conservation area: the church room on St Julian's Lane opposite the church and a building belonging to Shoreham College immediately southeast of the church. Both are utilitarian structures with flat roofs. While neither has a great streetscape presence, because they are set back well from the road and are single storey, neither is of high-quality design or materials.

Fig 20: Negative contributor south of the church within Shoreham College site

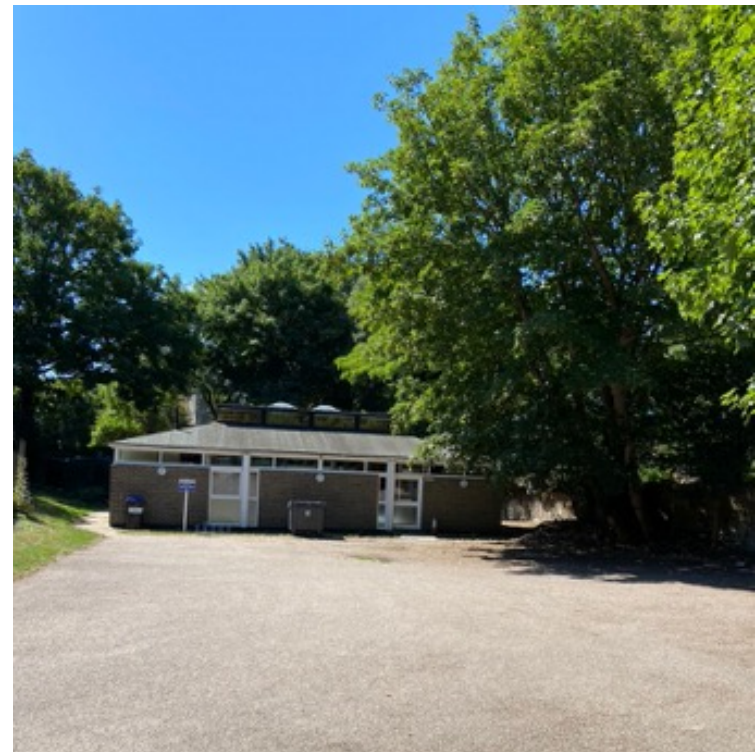
Fig 21: Church room

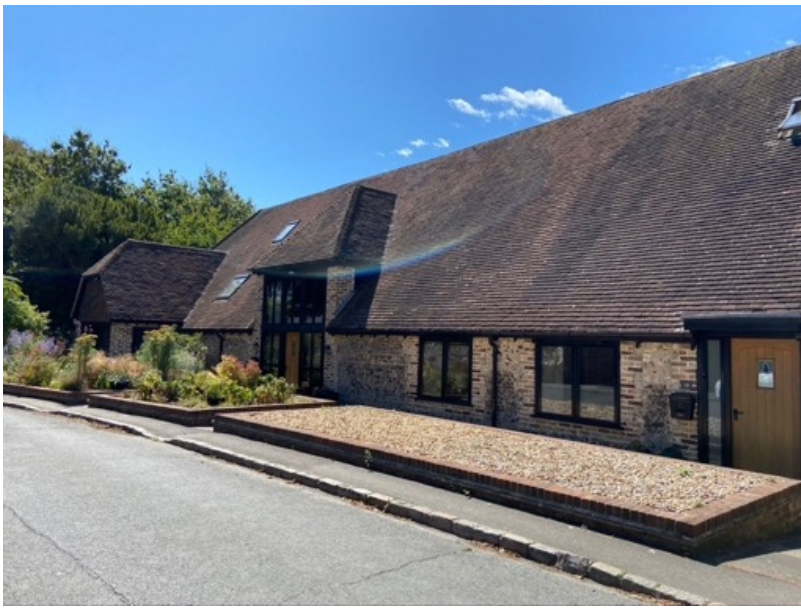
Fig 33: Domestic character of barn and setting
