Kingston Buci Summary of Significance

I.0 Kingston Buci Conservation Area: An Overview

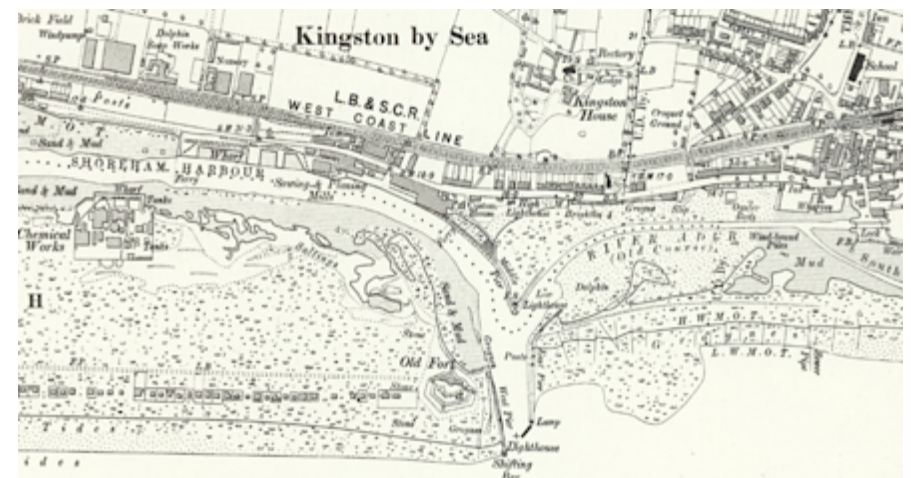
Fig 2: OS Maps of 1873 (top) and 1909 (bottom)

2.12 The setting of the historic manor of Kingston Buci itself remained largely unchanged until the post-war years when significant new housing was developed north, east and west of the manor, as shown in the OS map series below.

- 4.1 Much of the setting of the conservation area has been developed since the second half of the 20th century as indicated on the historic maps in Fig 2. The playing fields belonging to Shoreham College remain the only surviving green space that relates directly to the old manor house, and its importance is recognised in the map at page 3.

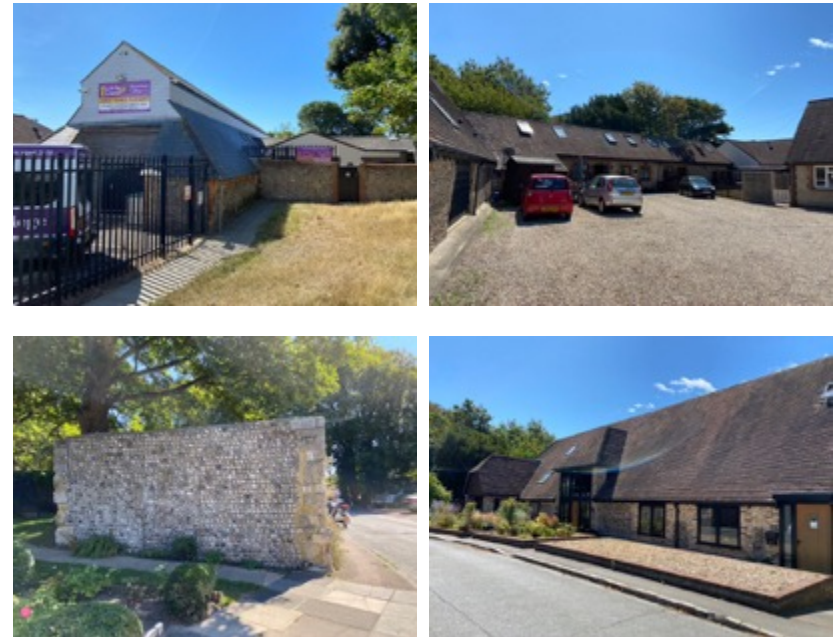
Fig 11: Former agricultural buildings associated with the manor house

- 3.15 The former agricultural buildings of the farmstead are now much altered. Only the tithe barn and the ruinous dovecote are listed. The barn has 17th century origins but has been subdivided and is now in residential use. The flint remains of the dovecote are likely to date from the 18th century. Within the grounds of Shoreham College, barns of early 19th century date have been converted to school use.
- 3.16 There are a variety of window styles among the historic buildings including the use of sashes at the old manor house, casements at the Old Rectory and various modern windows in former agricultural buildings elsewhere.

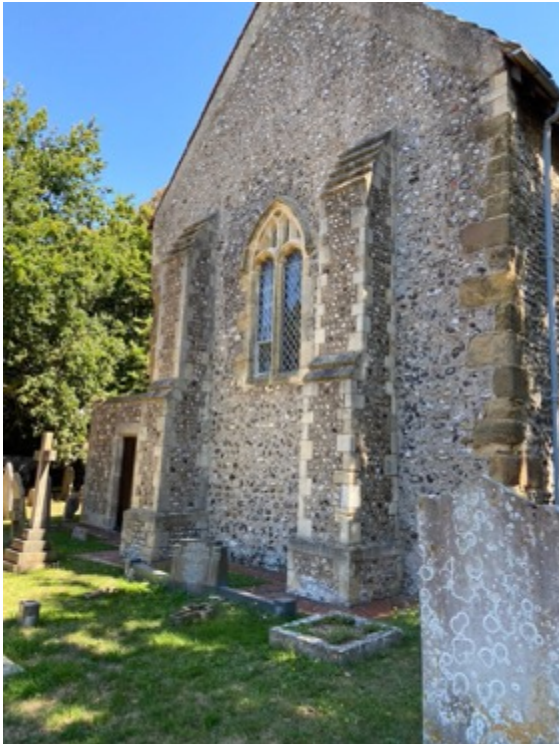
Fig 12: Flint rubblestone and Hythe stone dressings

- 3.17 There is little evidence of timber framing from the external elevations of historic buildings in the conservation area, although some timber framing is likely to be concealed in parts of the Old Rectory, tithe barn and possibly the manor house. The most commonly found broken flints are known as field flints, and would have been ploughed up for use in buildings. In higher status buildings there are examples of knapped and coursed flints. Flints are used extensively in both buildings and boundary walls, as intact cobbles or field flints; the south front of the manor is of knapped and coursed flints.

- 3.18 The church, manor, rectory and most of the former agricultural buildings all have flint walls, dressed either with brick (as at the Old Rectory) or stone (Shoreham College and the church). The Old Rectory has a substantial roof of Horsham slab stone, found throughout West Sussex, although uncommon in Adur. Elsewhere roofs are covered in tiles or slate. Modern housing within the setting of the conservation area is mostly brick, and uncharacteristic of the local vernacular materials.

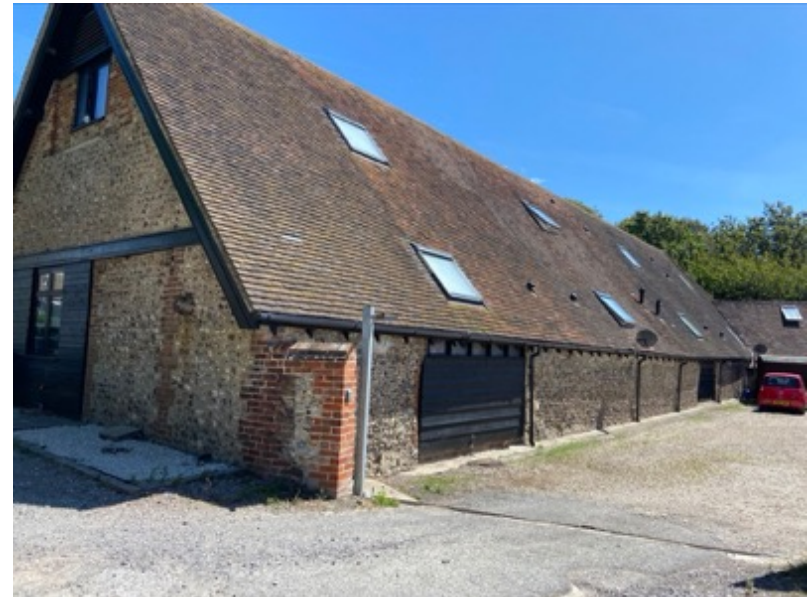
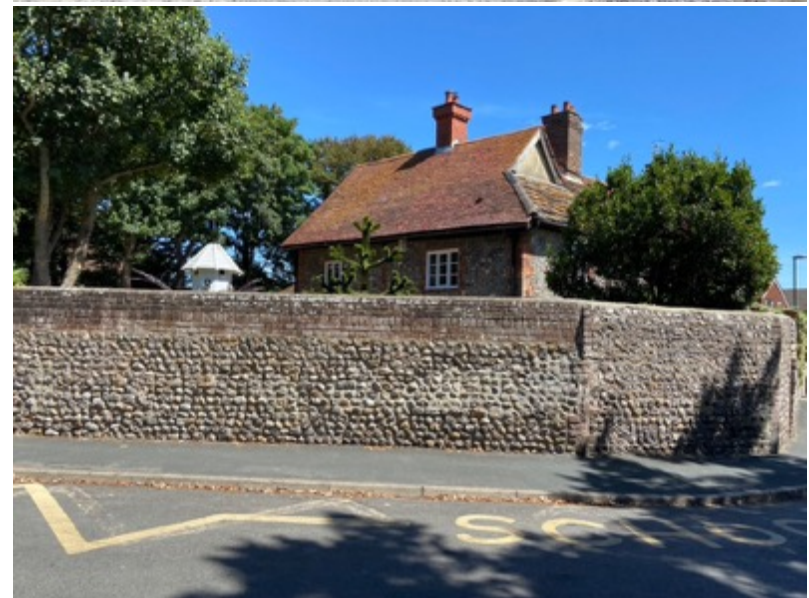
Fig 13: Flint walls, flint buildings with brick dressings and tiled roofs

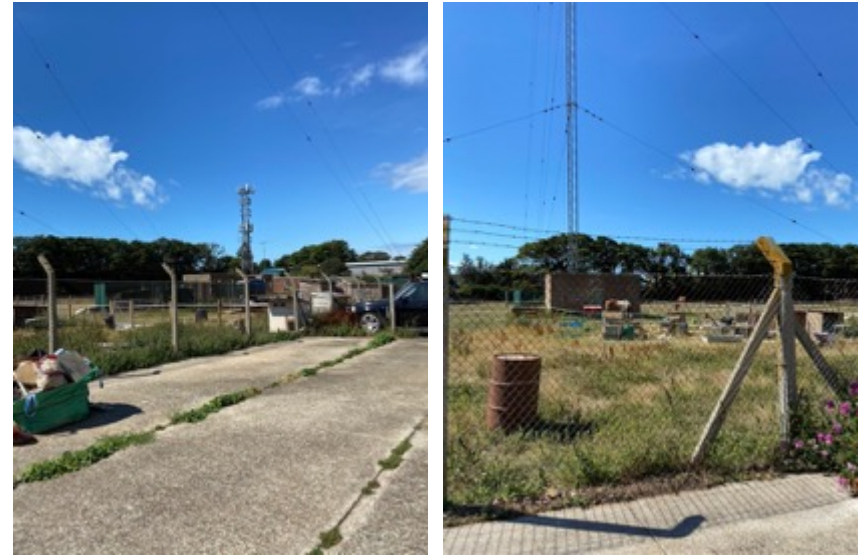
Fig 17: Transmitter station

- 3.31 The land south west of Shoreham College is used as a transmitter station and is poor quality open space with the substantial transmitter mast in its centre, along with transmitter infrastructure and shelters for grazing animals. It is bounded by high wire fences and parking courts belonging to modern residential housing. There are some historic flint boundary walls on the western edge of this site, likely to date from the 19th century, but their presence is not considered adequate to warrant continued inclusion of the space within the conservation area.

6.2 The site of the radio telecommunications mast is on land that was previously owned by the Southern Railway. The southern and western boundaries retain some historic flint walling, but the open space itself is in poor condition, and bounded by high security fences and parking courts. It makes no visual contribution to the conservation area and should be removed.

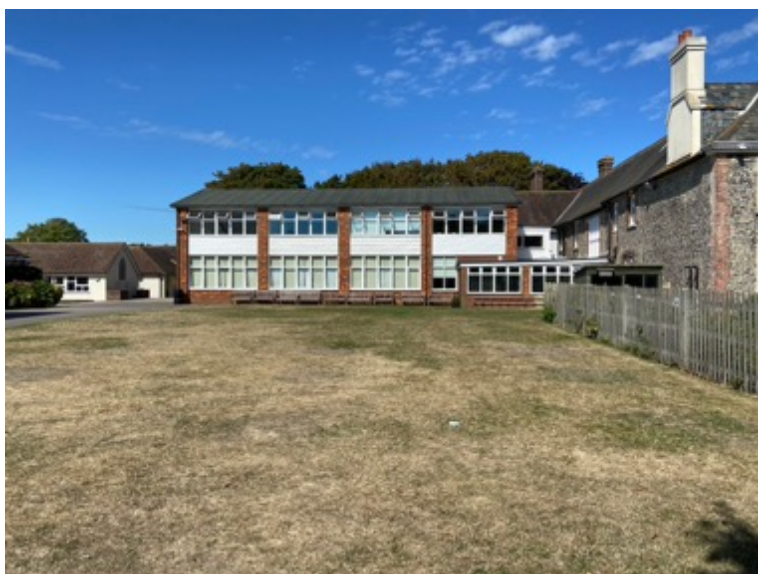
Fig 31: Disproportionate additions and inappropriate alterations to historic buildings

5.2 Shoreham College is responsible for the management of the majority of the land and buildings within the conservation area. The site is in general well maintained, although inevitably some of the modern development that has occurred is harmful to the significance of the listed manor house as derived from both the building itself and its setting. Nevertheless, the important views across the playing fields are maintained by the absence of significant boundary treatments, and the historic buildings are in active use with regular maintenance. There would be benefit in the school undertaking a Conservation Management Plan to guide future development needs at the school, and conserve appropriately the listed and curtilage listed buildings on the school's estate.

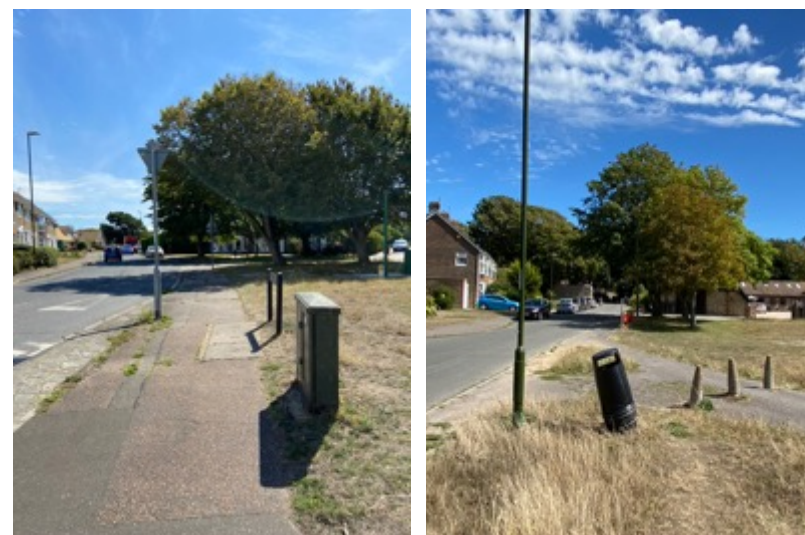
Fig 32: poor quality street furniture and surfaces along St Julian's Lane

- The north-west end of St Julian's Lane presents a poor arrival to the conservation area with poorly maintained road and pedestrian surfaces, ill-sited telecommunication boxes and bins. Similarly, the poor quality and condition of bollards and bins within the green buffer on the south-west side of St Julian's Lane detracts from enjoyment of the open space, and opportunities should be taken to upgrade and improve these elements.
- The parking compound of Shoreham College adjacent to the tithe barn detracts considerably from the appearance of the conservation area and the setting of the grade II listed barn.
- The conversion of some former agricultural buildings has eroded their original character
- The boundary treatment to the lawn tennis club is uncharacteristic close-boarded timber fencing and leylandii hedges.
